8 CLOSURE AND DECOMMISSIONING

A. INTRODUCTION TO ROAD CLOSURE AND DECOMMISSIONING

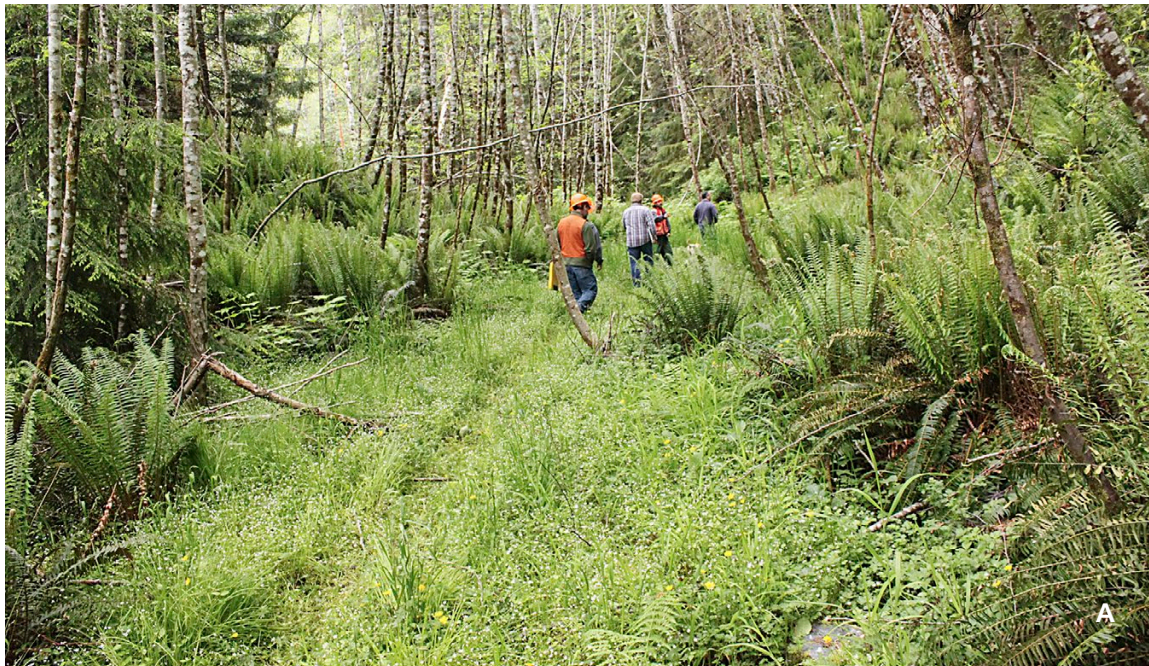
FIGURE 254A-B. Abandoned, unmaintained roads, whether in forested watersheds (254a) or in rural and ranchland areas (254b), represent a potential threat to streams and water quality.

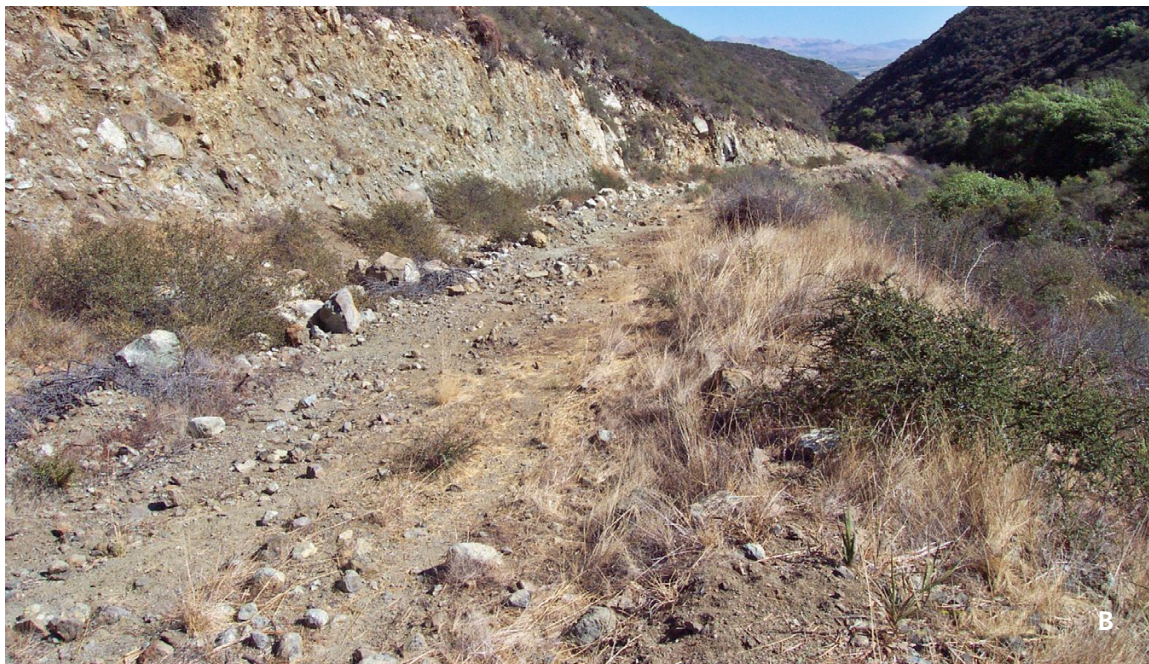
FIGURE 255.
Gully formed by culvert plugging and stream diversion on an old, unmaintained forest road. The degree of threat posed by old roads depends on the terrain the road crosses. Typically, the most serious threats occur where roads cross stream channels and steep, wet and/or unstable hillslopes.

Because of their age and low standard of construction, and where they may have been built, old abandoned roads can still pose a significant environment threat to a watershed and its streams. **Just because a road has been abandoned and may be overgrown does not mean it is no longer a threat to the watershed (Figures 254a and 254b). Some failures may have already occurred along an abandoned or legacy road, but others are often still waiting to happen years or decades later when culverts finally plug or unstable fill slopes fail (Figure 255).**

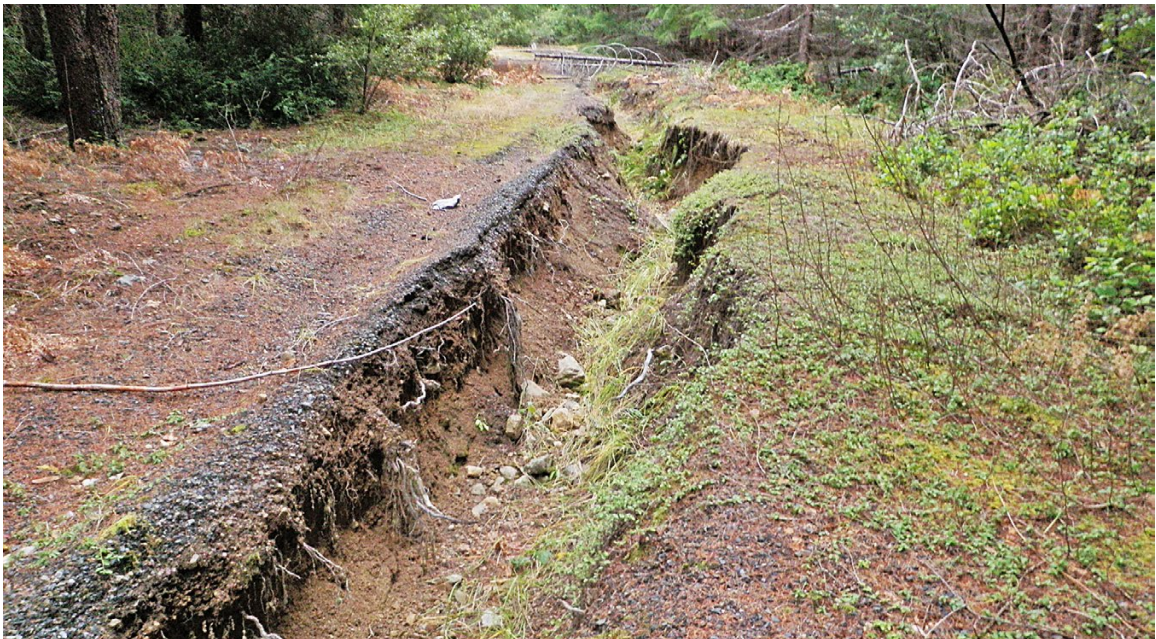
FIGURE 256.
Unmaintained, culverted stream crossings, like this one, will eventually plug and either wash out or divert streamflow down the road. Most abandoned roads have drainage structures that are very undersized and often rusted through. Damage from the diversion of even small streams can cause large gullies or debris slides when released on steep, erodible slopes.

Many orphan roads have drainage structures, including stream crossings, which are in disrepair and are no longer being inspected or maintained. Some of the most vulnerable sites may have already failed, but others are likely to fail in the future (Figure 256). These abandoned, legacy roads often represent

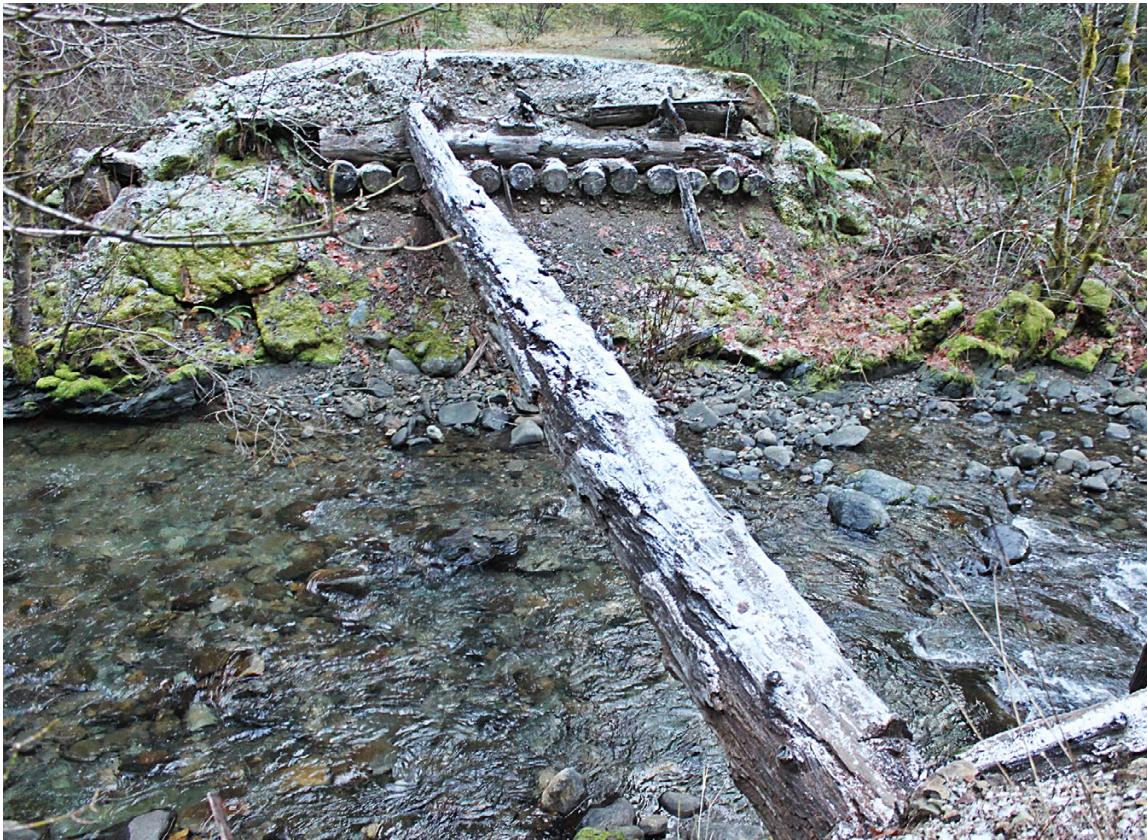
FIGURE 257. Former log stringer bridge across a large fish bearing stream has been removed, with only a single log for left foot traffic. The bridge provided the only access to over two miles of forest road containing numerous culverted stream crossings that can no longer be maintained. Roads that have not been properly decommissioned require inspection and maintenance. The roads on the other side of this bridge have recently been scheduled for decommissioning.

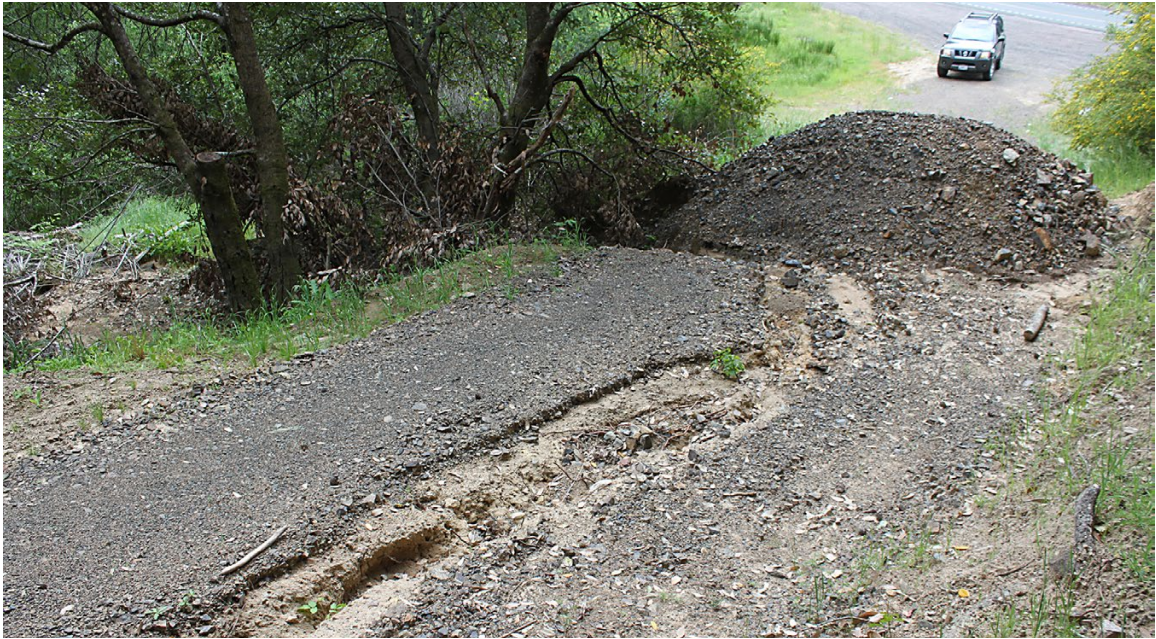
FIGURE 259. Gating a road closes it to unauthorized traffic and may reduce surface erosion, but does nothing to protect the road from major failures. Scarps in the road fill behind this gate signal a slope failure that threatens to deliver sediment to an adjacent fish-bearing stream if it is not treated.

It is no longer sufficient to close roads by simply installing or locking a gate or blocking the road with an impassable barrier, because those actions will not prevent future road failures, erosion, sediment delivery, or water quality problems from occurring (Figure 259).

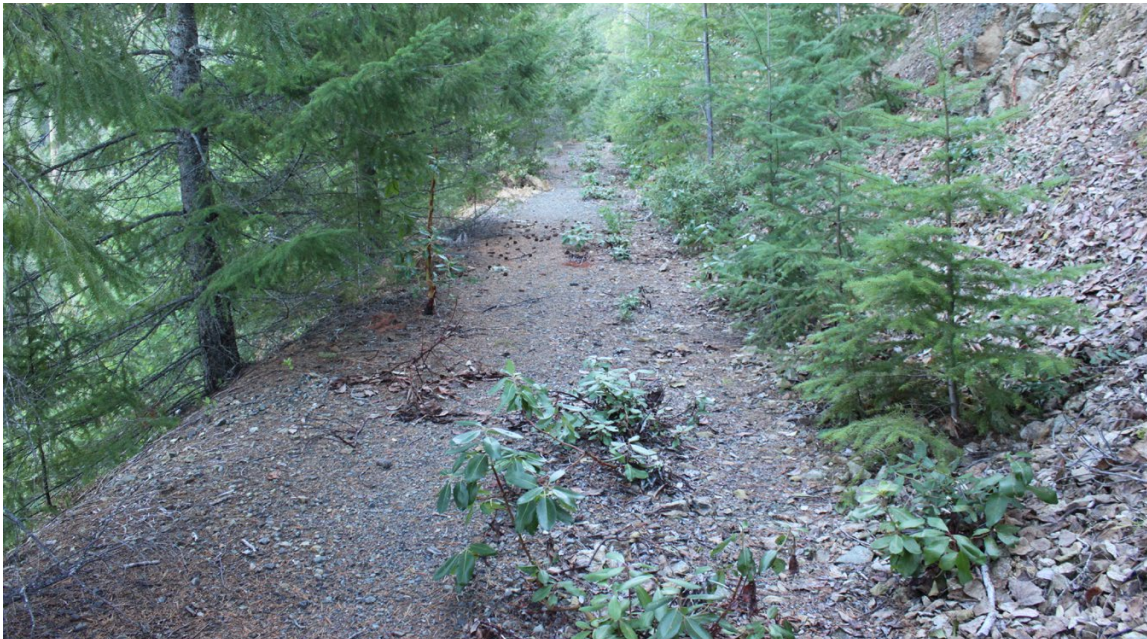
**FIGURE 260.**

Untreated, abandoned section of forest road does not threaten water quality and needs little or no treatment for decommissioning. Roads to be decommissioned typically require minimal treatment for most of their lengths, and then concentrated erosion prevention work at a relatively few locations (e.g., stream crossings).

Closing a road does not imply that every foot of the road needs intensive treatment to prevent future erosion (Figure 260). **Rather, the goal of proactive road closure is to aggressively treat only those sites and road segments which have a potential to generate erosion and to deliver sediment to stream channels.** Segments of road which pose no risk of sediment delivery can be left intact and receive only minimal road drainage

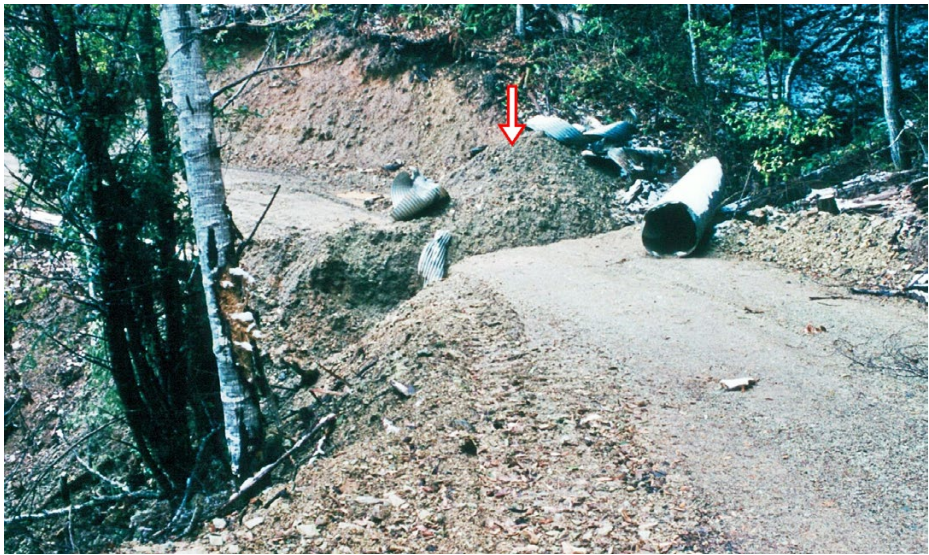
FIGURE 265. Properly decommissioned stream crossing, with 2:1 (stable) sideslopes, adequate channel width for flood flows, and a uniform channel grade (no humps of unexcavated fill) extending between the natural channel above and below the crossing. Because the slopes were dry, excavated spoil material was used to outslope the adjacent road approaches. The sideslopes were seeded with grass and straw mulched to minimize erosion following decommissioning.

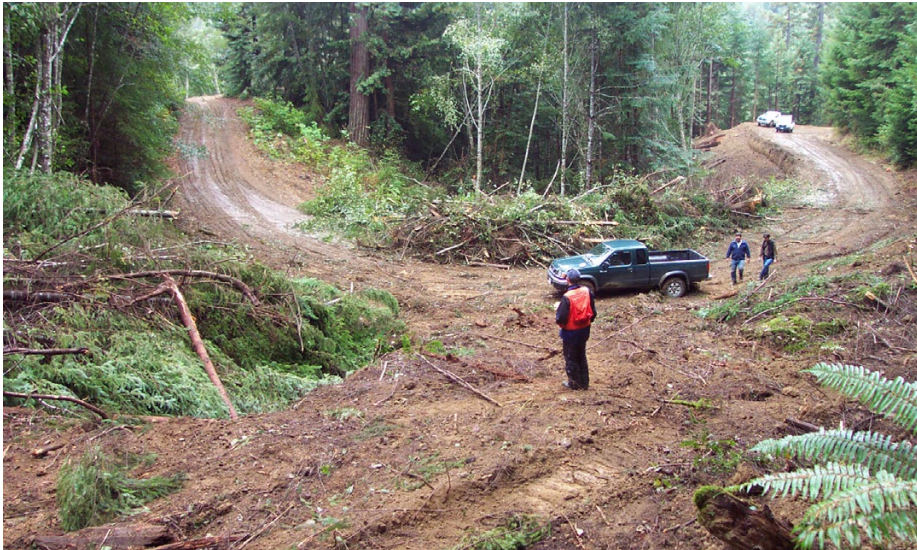
FIGURES 266A–E. This five-photo sequence shows the permanent decommissioning of a stream crossing on a former logging road. The road was no longer needed and has been permanently closed. The first step (266a) was to clear vegetation from the fill and from upstream of the crossing, where the channel had been filled with logging debris several decades earlier.

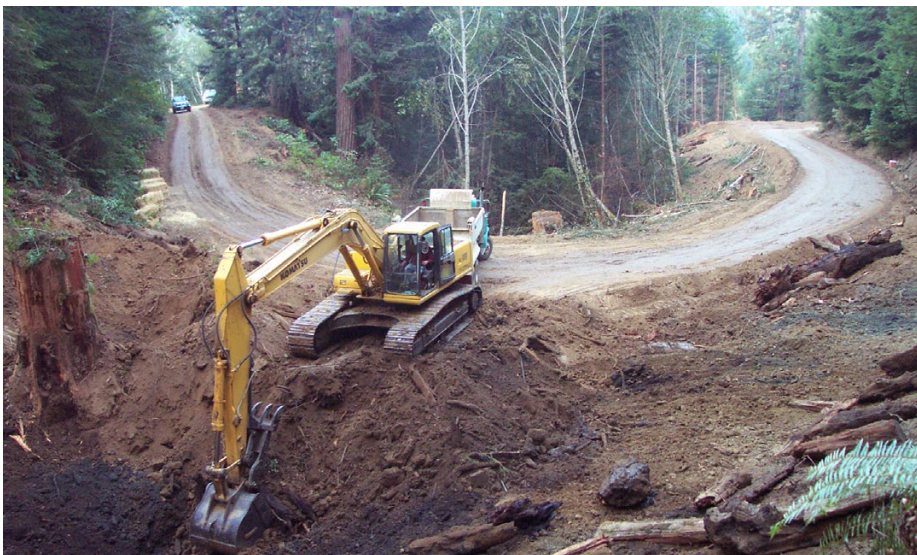
FIGURE 266B. Once cleared, an excavator excavated the fill material and several dump trucks were used to end-haul spoil material to a nearby, stable disposal site.

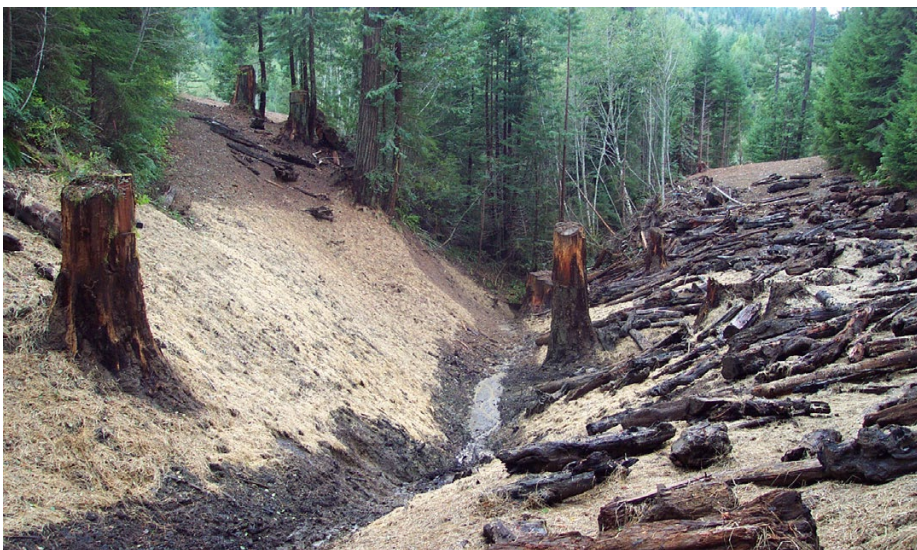
FIGURE 266C. The channel was excavated (exhumed), and the side-slopes were sloped back to stable angles, exposing several buried stumps that signaled the level of the original ground surface. The bare slopes were then seeded, mulched with straw, and planted with trees. All the logs visible on the right bank had been buried in the crossing fill. They were removed and placed on the final ground surface.

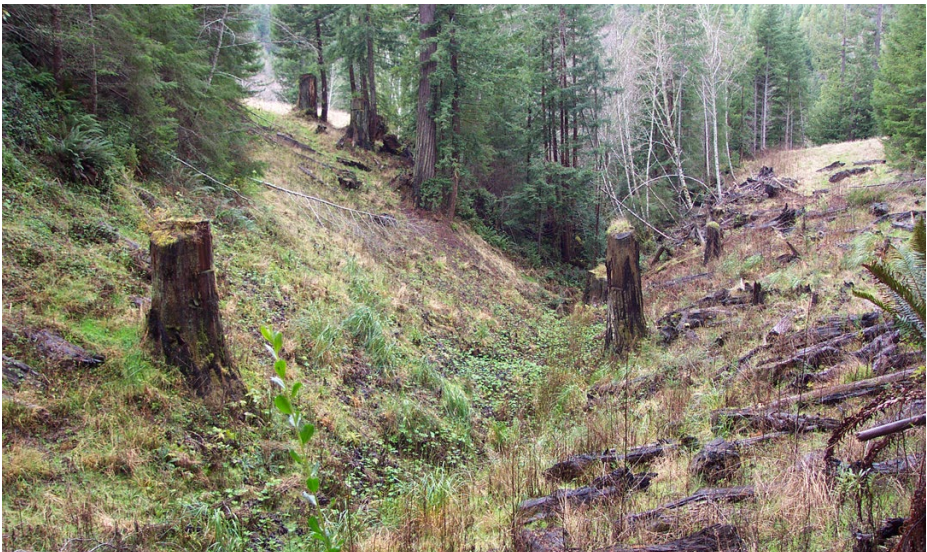
FIGURE 266E. Finally, 2 years later (and 6 years after decommissioning) the site showed heavy alder growth that had naturally seeded in from adjacent areas. The conifers beneath the alder canopy will eventually overtake the alder trees.

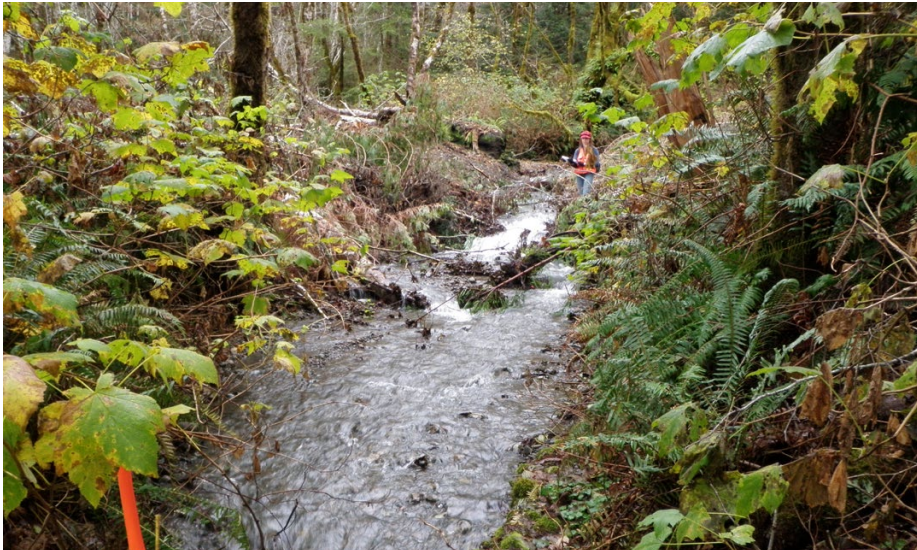
FIGURE 267B. The stream crossing fill was excavated and pushed down the alignment, away from the crossing. The gentle, excavated sideslopes were seeded, mulched with straw and covered with locally derived tree limbs and brush. The channel was excavated to the original streambed elevation, where rounded cobbles were exhumed, and constructed with the same width as the upstream and downstream channel reaches.

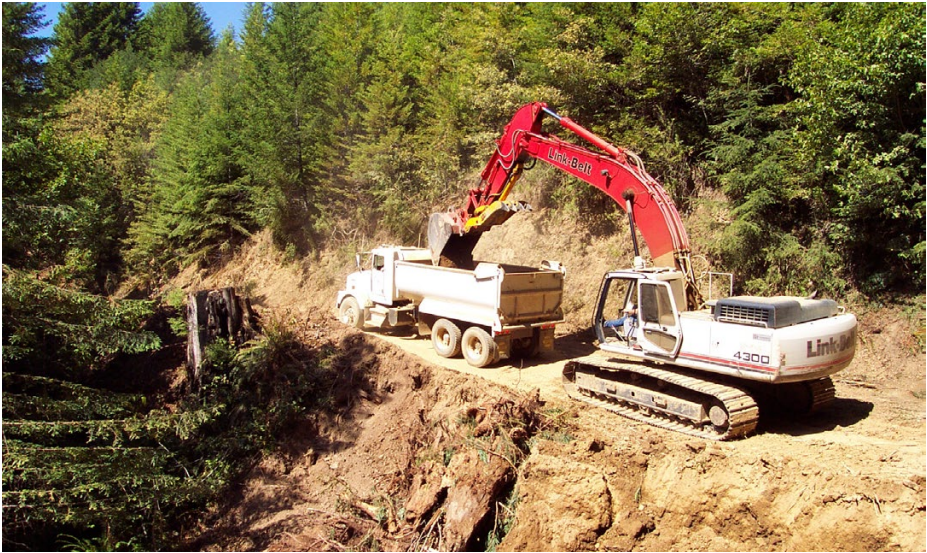
FIGURE 269B. This low standard forest road was scheduled for decommissioning because of slope stability and erosion problems along its alignment. Prior to road grading, inventory crews had identified cracks and small scarps along 50 feet of the road bench and outer fill. If it failed, the debris slide would deliver sediment to a stream just downslope.

i. Road and landing fill slope excavation
Any unstable or potentially unstable road or landing fills (or sidecast) should be excavated and stabilized so material does not fail and enter a watercourse, impact off-site fish habitat, threaten bridges or homes that may be located downstream, or destroy down-slope vegetation. Such areas include sidecast and fill materials which show recently developed scarps or cracks (e.g., [Figures 269a—269c](#);

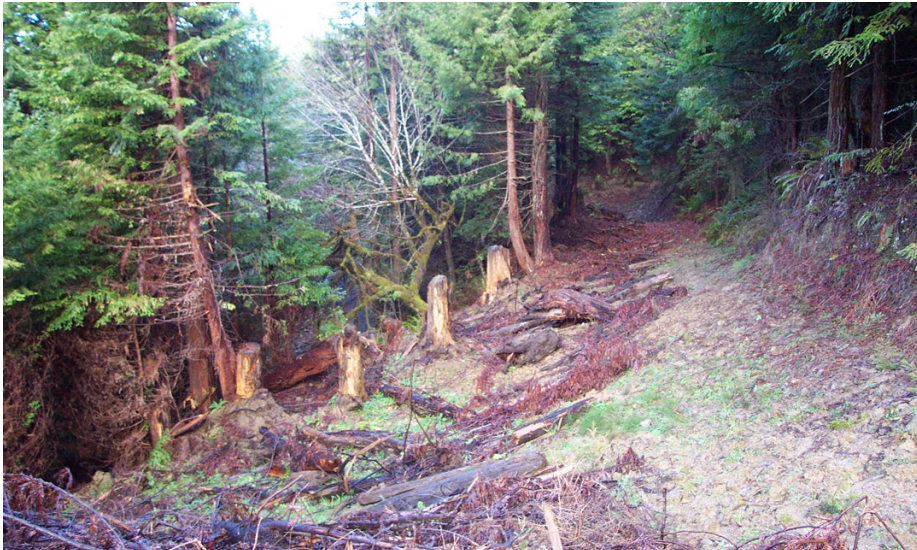
FIGURE 269C. The fill slope has been excavated and the spoil endhauled to a nearby spoil disposal site (exported outslope: EOS). Note the buried stumps that were exhumed and the basal flair that told the excavator operator where the original ground surface was located and how deep to dig. The cutbank has not been buried so the resulting outslope of the former road bench is strictly a result of roadbed and fill slope excavation.

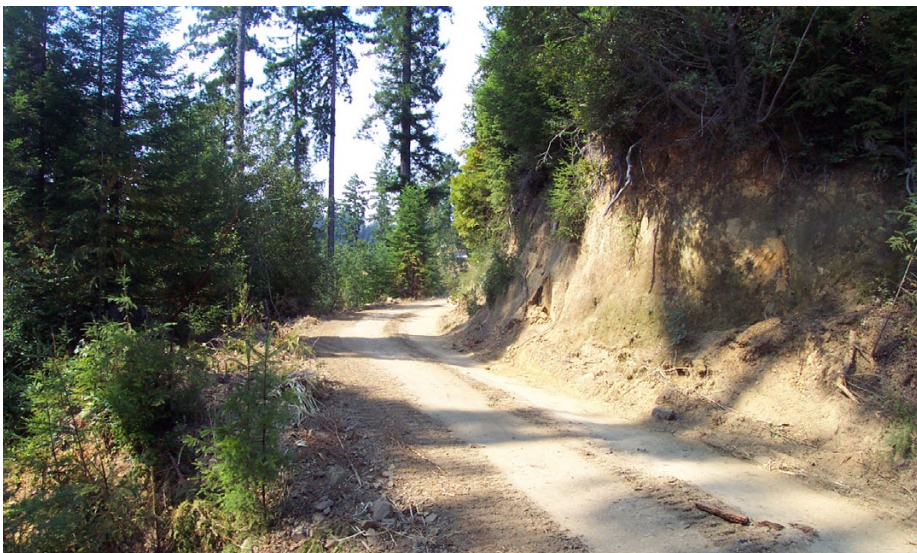
FIGURE 270A. Tall, dry cutbank where the road cut across the nose of a ridge. Just down the road an unstable fill was excavated to prevent a potential fill slope failure and this favorable site was used for spoil disposal.

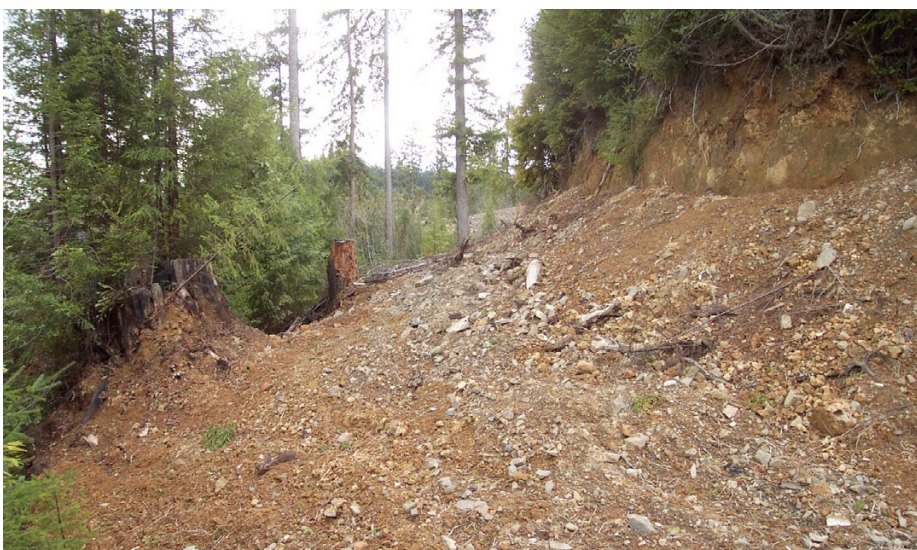
FIGURE 270B. Spoil excavated from the nearby unstable fill slope was hauled to this section of road and placed (and compacted) against the cutbank. This type of treatment is called an "Import Outslope" (IOS), where most of the fill used to outslope the former roadbed was imported from another, nearby excavation site. Using local spoil disposal sites, provided they are suitable, can save significantly on endhauling costs.

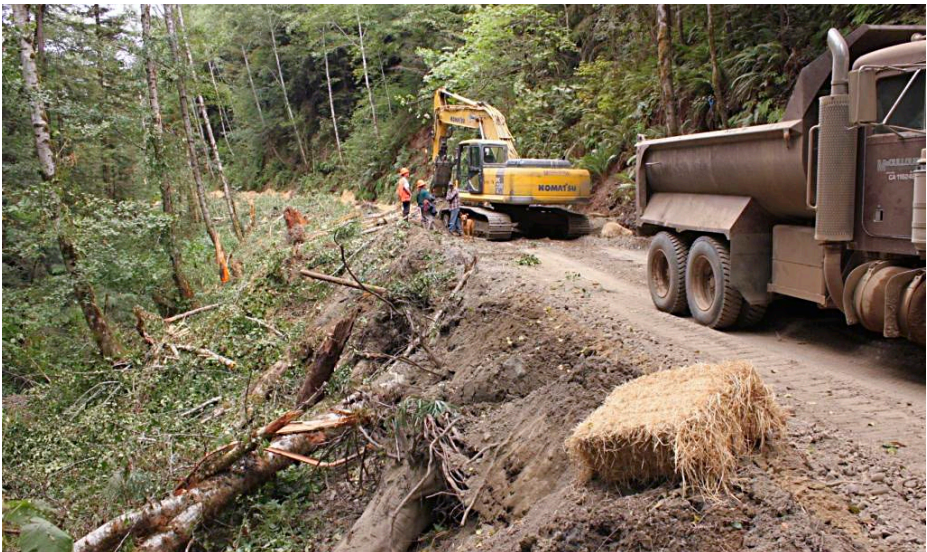
FIGURE 271B. After decommissioning, all the potentially unstable fill material has been excavated and endhauled off-site. Some excavated material has been placed along dry portions of the cut-bank, but seeps and springs have been left uncovered to freely drain down the slope. The excavated fill slope and road bench has been covered with alder trees that were growing on the slope, and the remaining bare soil areas were seeded and mulched with straw. The threat to the stream at the base of the slope has been eliminated.

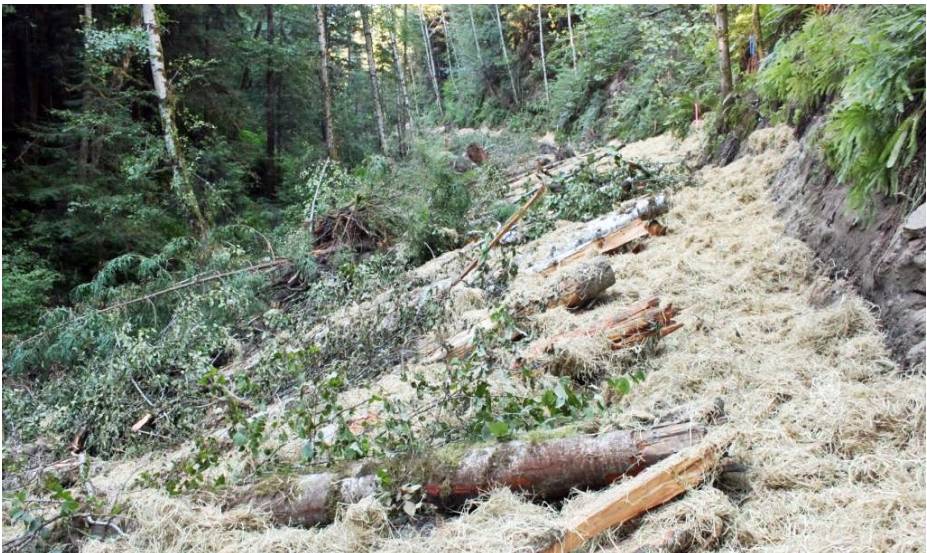
FIGURE 272A. Log landing on a forest spur road had developed large cracks and scarps around its outside perimeter where soil and wood waste had been sidecast onto steep slopes above a fish bearing stream. The fresh scarps had developed over several years and were identified by an inventory crew surveying for erosion problems in the watershed. An excavator is beginning the fill slope excavation and spoil material was pushed against the inside of the landing by a bulldozer (not visible).

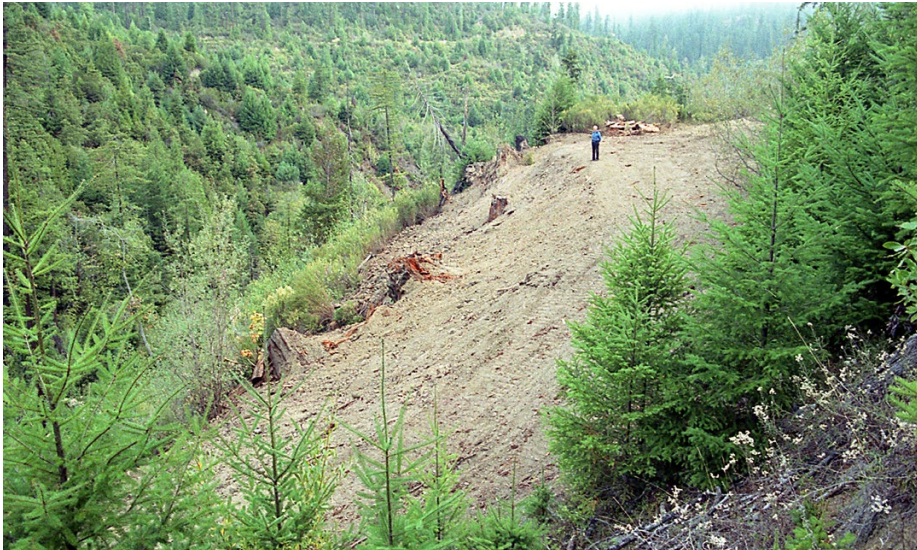
FIGURE 272B. The excavation required a temporary road be built across the middle of the long fill slope to reach all the unstable material. The concave excavation surface mimics the shape of a potential slide plane and thereby assures that most of the unstable fill material has been removed. Spoil materials were pushed up against the inside of the large landing, entirely on a stable, excavated bench. As in Figure 271B this type of out-sloping is called an “Inplace Outslope” (IPOS), where all the excavated materials were stored locally (note person for scale).

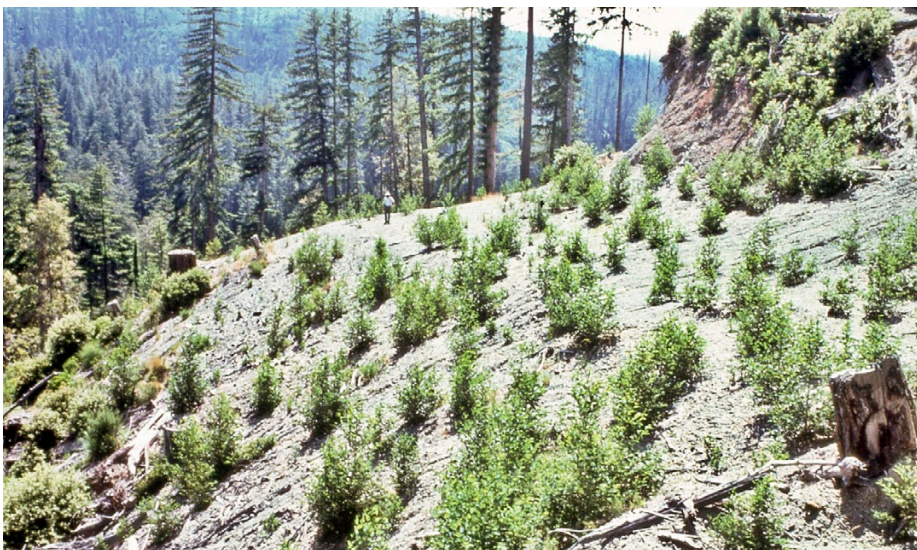
FIGURE 273B. Using Inplace Outsloping (IPOS) techniques, the rocky sidecast soils were excavated and placed against the tall cutbank of this dry ridge. Woody debris was separated from the dirt and chipped for mulch. Three years later, alder trees have invaded the bare soil surface and were rapidly growing. Minor surface erosion and rilling had occurred while the surface was sparsely vegetated, but there was no sediment delivery to a stream (note person for scale) (RNP).

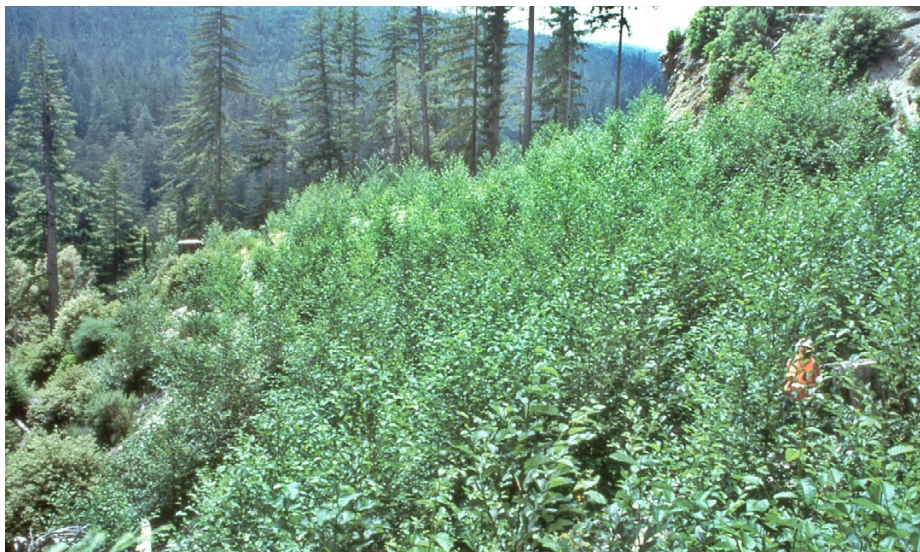
FIGURE 273C. By the following year, rapidly growing alder trees had completely covered the decommissioned, outsloped landing surface and surface erosion rates were near zero. The threat posed by the unstable fill was completely eliminated by the decommissioning treatment (note person for scale) (RNP).

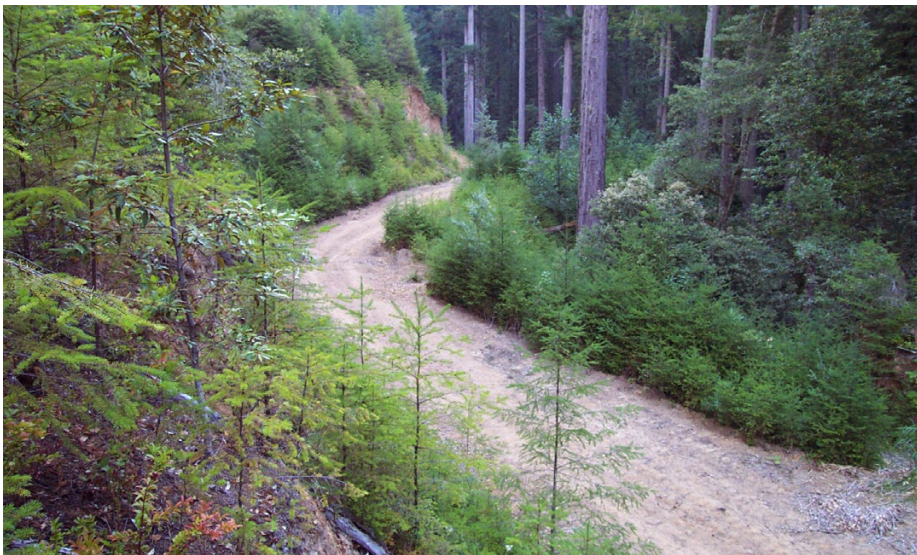
FIGURE 274A. Abandoned forest road that was reopened for decommissioning and erosion prevention treatments. The proposed treatment was to completely restore and recontour the hillslope in this biological reserve and conservation area.

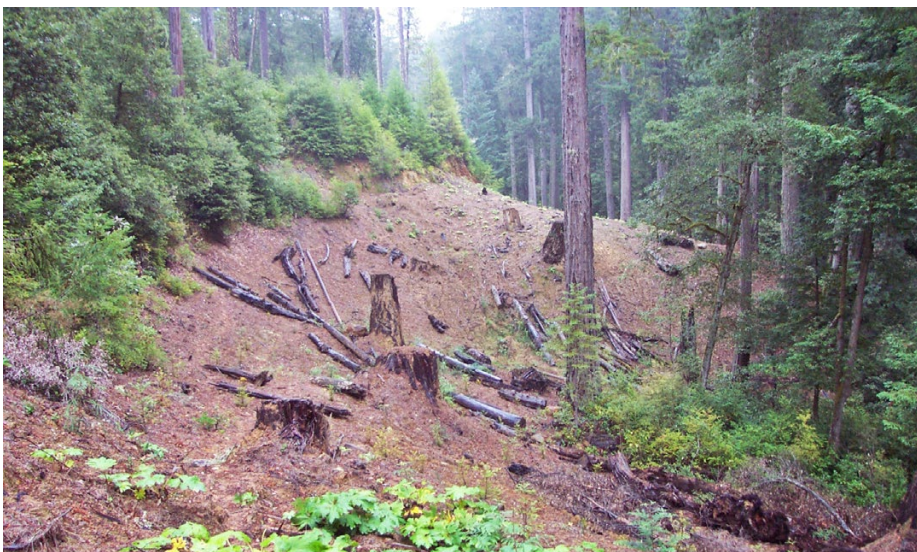
FIGURE 274B. After treatment, remnant stumps that had been buried by road construction and sidecasting were exhumed and gave the excavator operator a good idea where the original ground surface had been located. The outsloping was performed with little or no endhauling, as fill materials from the outside of the road prism were excavated, placed and compacted against the dry cutbank. Most of the cutbank has been buried and the slopes recontoured to their original form. The exposed soil was not seeded with grass, and rice straw was used as a mulch to prevent the introduction of non-native weeds. Litter from the adjacent forest quickly covered the surface.

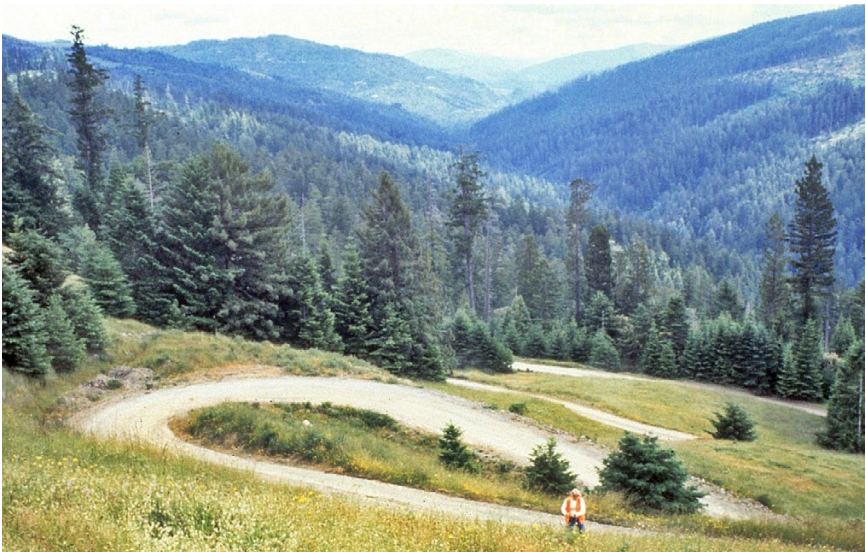
FIGURE 275B. Because of the wide and scenic vistas, and the expected use of the grasslands by future park visitors, these roads were decommissioned by full recontouring (road obliteration). Within two years, the recontoured roads and slopes had been invaded by native grasses and their presence was barely noticeable (NPS, RNP).

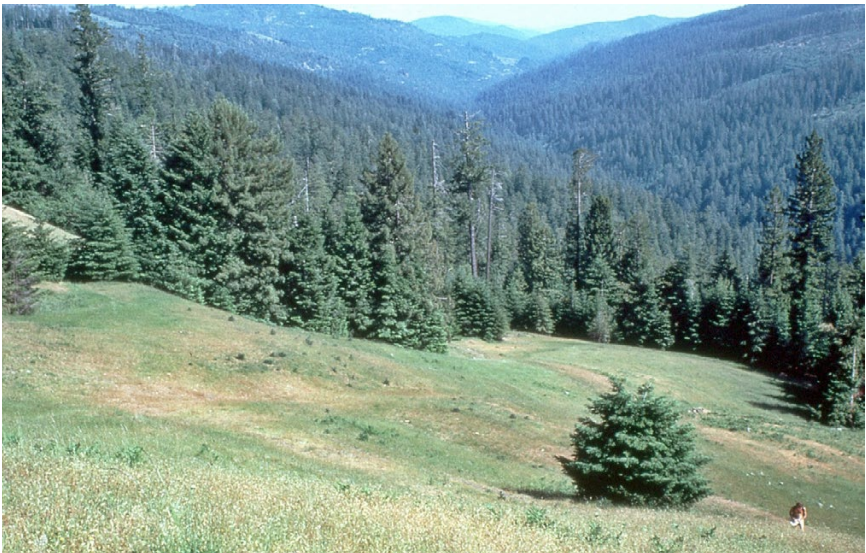
FIGURE 276. This road-to-trail conversion (decommissioning) was undertaken when the forested area, once commercial timberlands, was acquired and converted to a biological preserve. Part of the ecological mandate was to decommission former logging roads to reduce erosion rates to protect streams and fish habitat, while still preserving hiking access to many of the biologically unique areas. Here an excavator is recontouring a former logging road while constructing a new trail near the top of the old cut slope. The surface of the recontoured slope has been mulched with limbs and woody debris. All stream crossings and unstable road fills have been excavated along the old road alignment.

is performed to convert from vehicle use to narrower, non-motorized visitor use trails (**Figure 276**). Many of these former roads are converted directly to narrow pedestrian trails along the original alignment, with detours around hazards or excessively steep pitches, or to provide access to open vistas or points of interest (**Figures 277a and 277b**). Other trails are kept comparatively wide and low gradient to allow for emergency vehicle access or to provide for access and use by disabled persons (**Figure 278**; **Figures 279a and 279b**). Road to trail conversions are still designed to provide for an access route that removes most of the original and most serious threats

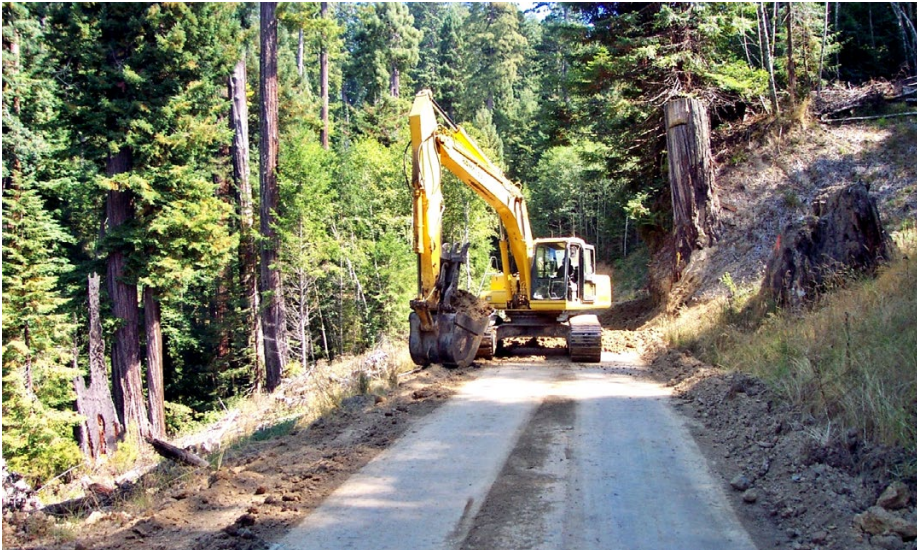
FIGURE 277A. Former private forest road, now in a U.S. BLM Biological Reserve, has been scheduled for out-sloping and conversion to a trail. The purpose of the decommissioning project was to recontour the old logging road and convert the route to hiking access for visitors and researchers. Note the stump in the right foreground.

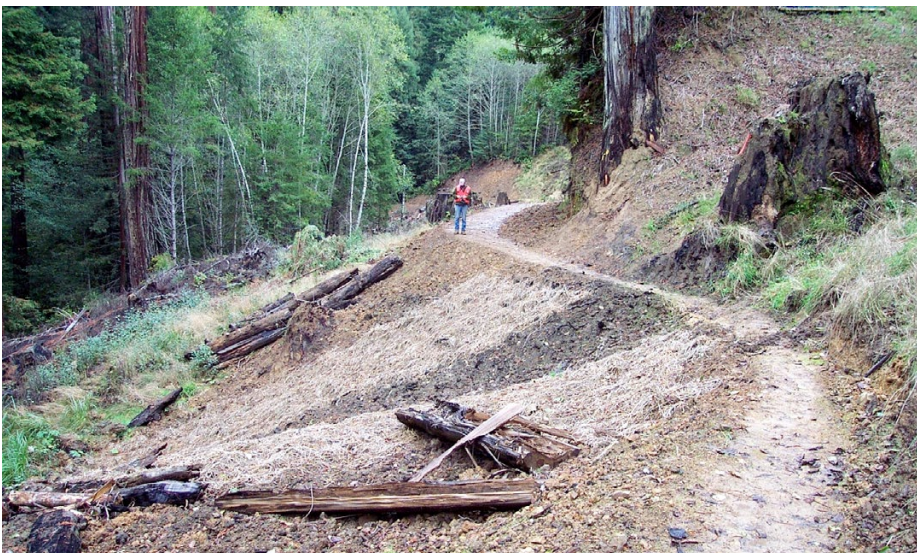
FIGURE 277B. The former road was decommissioned by excavating the sidecast fillslopes and placing the excavated fill against the dry cut banks. The excavated fillslopes were covered with rice straw and woody debris to control erosion while preventing the introduction of exotic grass and weed species. The once-straight road has been converted into a winding trail that follows the original landscape contours. Topographic swales and stream channels have all be excavated and recontoured

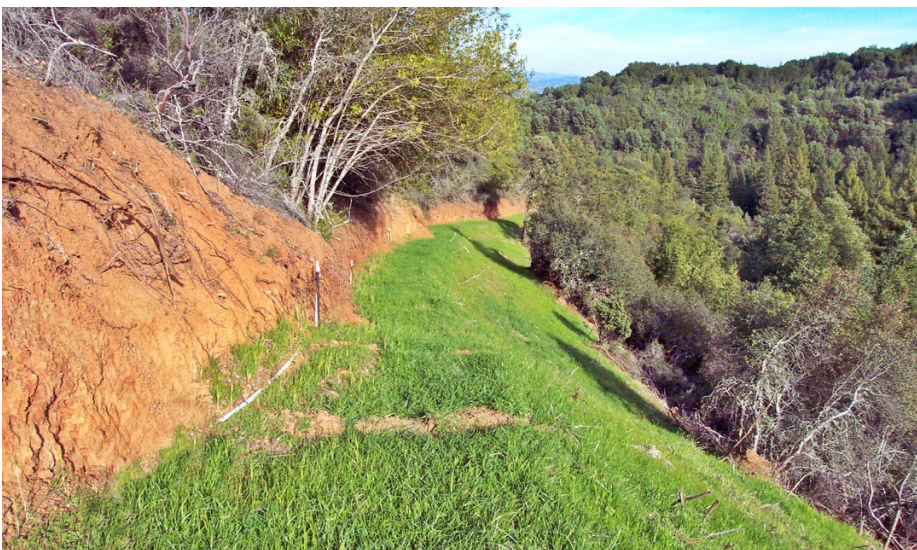
FIGURE 278. An illegally constructed road had been built across this steep hillside to access a new home site. Because of high erosion rates and slope instability, and because it was not permitted, regulatory agencies required the road to be fully decommissioned and recontoured. After excavation and recontouring, the bare slopes were seeded and watered to achieve a rapid and complete groundcover of grass. The decommissioning was approved to include a narrow trail for use as an emergency fire escape route, using small quads (off-road vehicles). A new and better alignment to reach the home site was subsequently found and constructed through proper permitting processes.

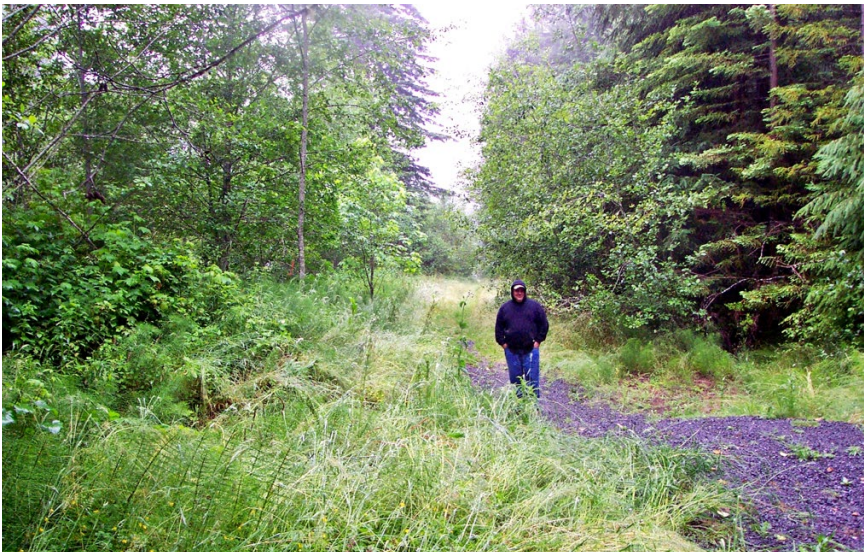
FIGURE 279B. In the same view as Figure 279a (note the conifer tree now clearly visible), the unstable road fillslopes next to the fish-bearing stream (left, off photo) were excavated and the fill used to recontour the old road cuts and restore the site's original topography. Because it was in a new U.S. BLM conservation area, bare soil areas created during decommissioning were mulched with wood chips generated on-site. A compacted gravel surface was then installed to make the trail accessible to all visitors.

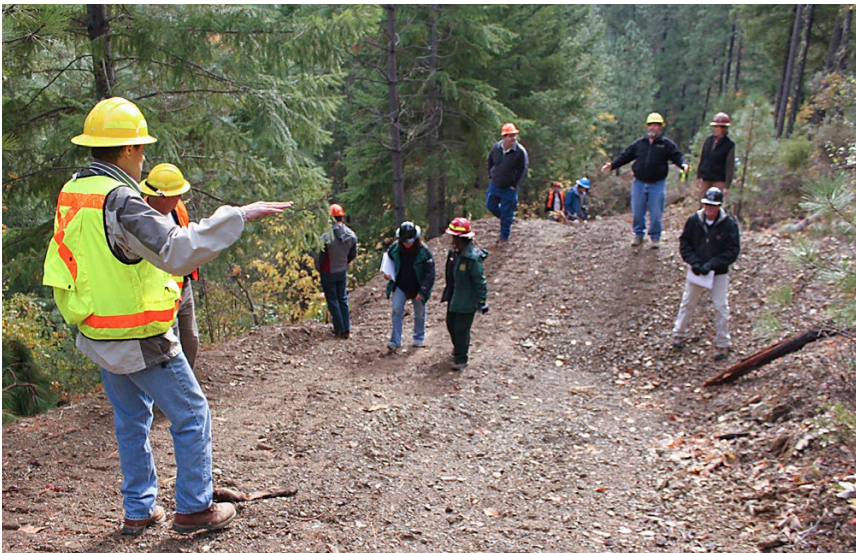
FIGURE 281. Between treated stream crossings and fill slope excavations, decommissioned roads should have permanent road drainage treatments, including road decompaction (ripping or subsoiling) and constructed cross road drains. Cross road drains are permanent road drainage features, like waterbars but much more substantial so they will function indefinitely and will not be broken down by rainfall, runoff or any kind of unwanted recreational traffic (usually bicycles or motorcycles). Like waterbars, they are usually excavated into the firm roadbed, mounded on the downhill side and spaced closely enough to prevent significant erosion on the roadbed or below the point of discharge.

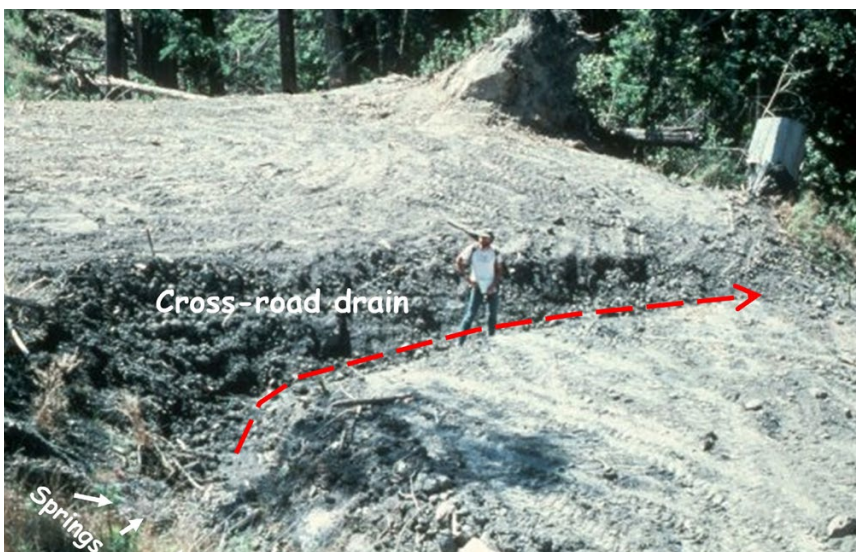
FIGURE 282. Deep cross road drains are constructed everywhere there is a spring or seep on the former road cutbank. This helps drain the road and the hillslope as uniformly and frequently as possible. Except for very short sections next to a cross road drain, inside ditches should not be retained.

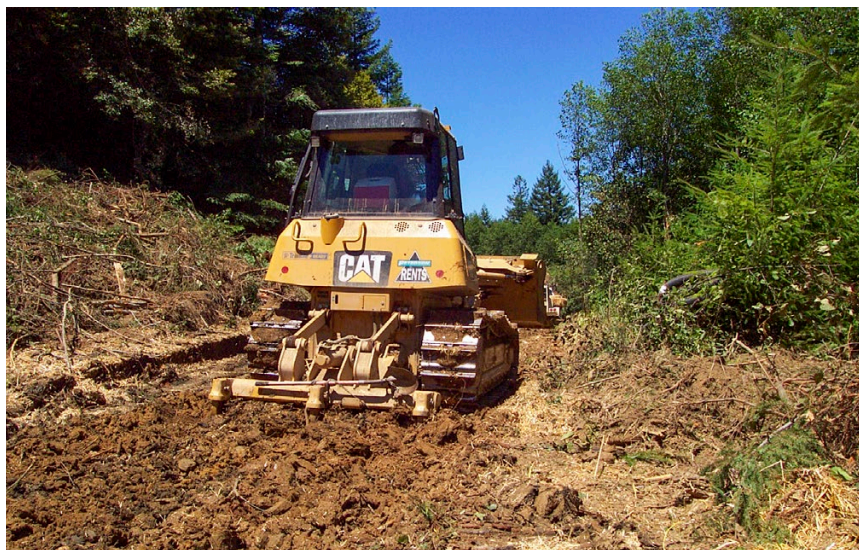
FIGURE 283. *Small bulldozer with hydraulically operated rippers (three 30 inch long steel chisels) is decompacting a seasonal road as a part of road decommissioning. Road ripping should be a standard decommissioning practice. All decommissioned roads should be ripped to decompact the road bench, improve and speed revegetation and reduce surface runoff. If the road is to be outsloped, and spoil is placed on the former roadbed, the compacted road bench should first be ripped to a depth of 18 to 24 inches, or greater. If it isn't ripped, infiltrating water will pond on the compacted surface and may cause soil saturation or contribute to slope failure.*

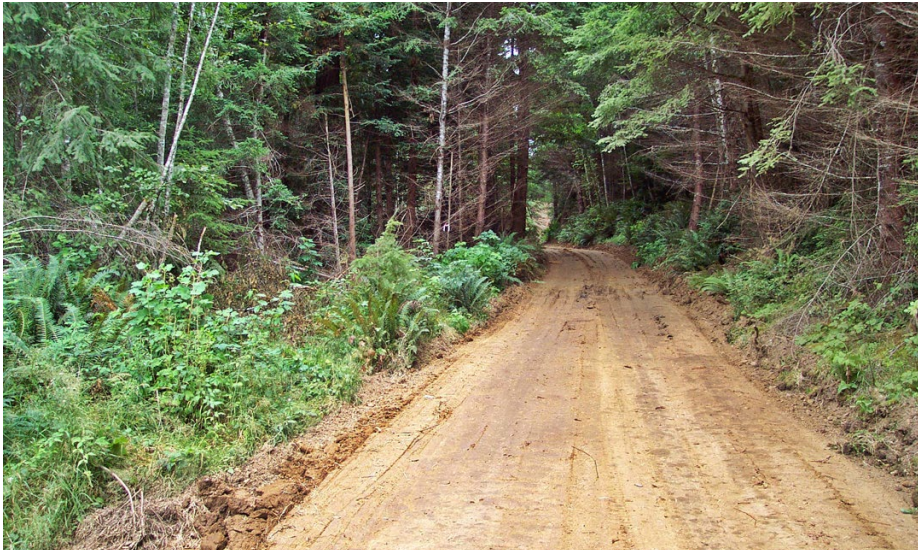
FIGURE 284A. On forest roads which are to be formally closed, rather than just “abandoned,” the roadbed can be returned to forest or grassland production by ripping and disaggregating the surface and then planting with trees. Figures 278a and 278b show a road before and after ripping and decompaction. This simple, inexpensive treatment also helps reduce runoff from compacted areas. It is recommended that enough passes be made with the tractor so the surface is completely disaggregated.
