8 CLOSURE AND DECOMMISSIONING

A. INTRODUCTION TO ROAD CLOSURE AND DECOMMISSIONING

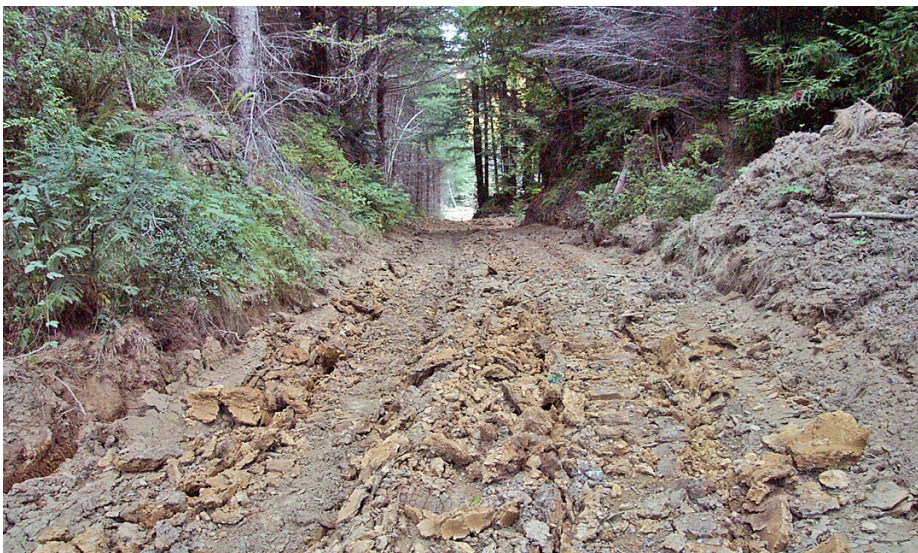
FIGURE 284B. A road after ripping and decompaction.

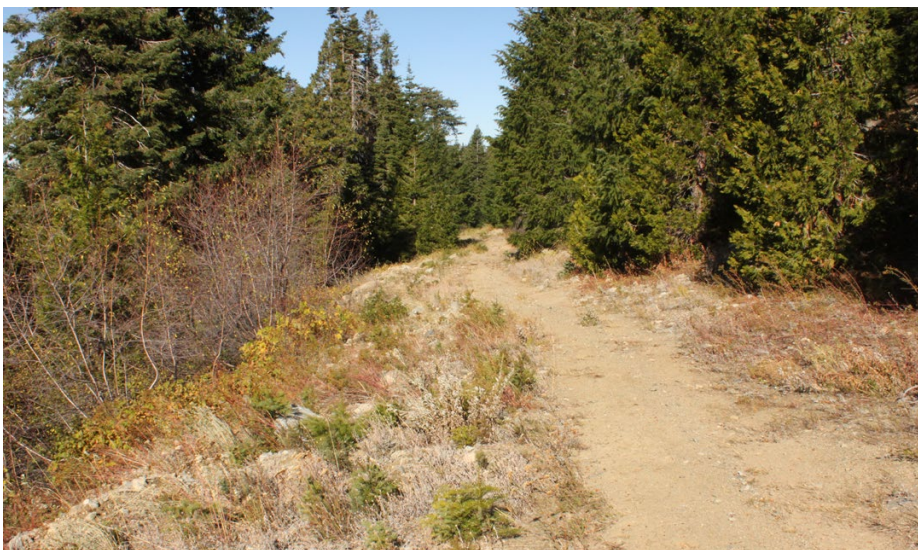
FIGURE 285. Former forest road that has been ripped, slightly outsloped and converted to a hiking trail. The decommissioning treatment needed in this upper hillslope setting was minor and yet largely eliminated surface runoff from the alignment.

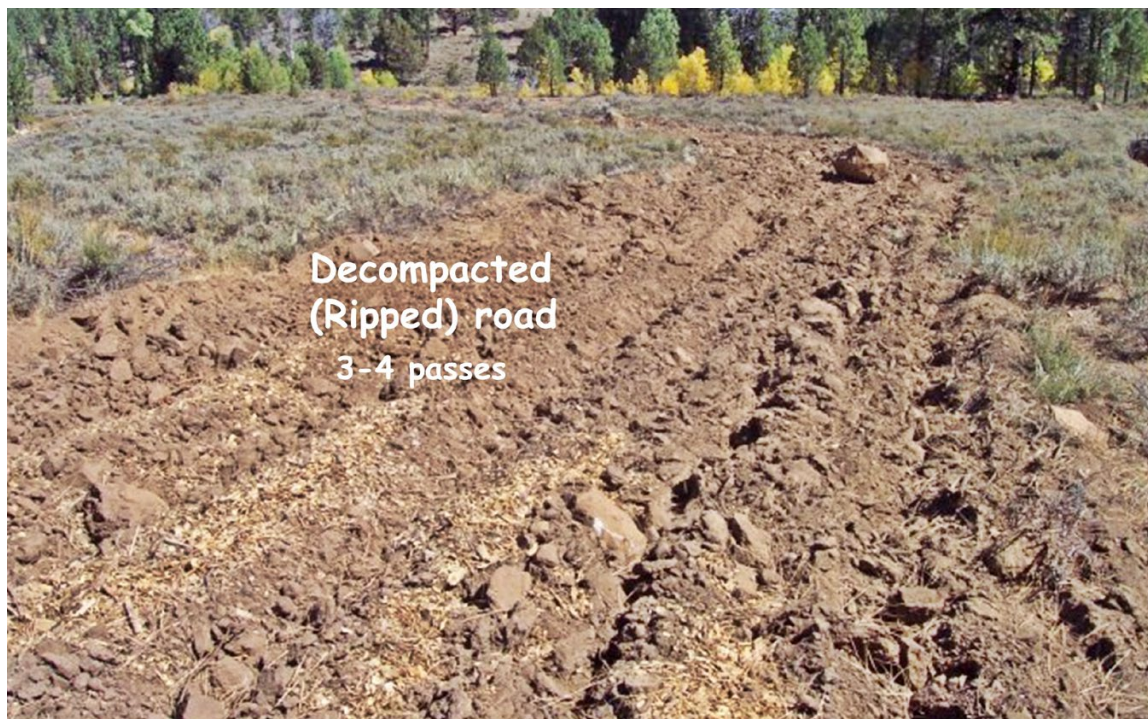
FIGURE 286. *On gentle terrain, ripping (soil decompaction) maybe the only treatment that is needed to decommission a road, eliminate unwanted traffic, reduce runoff and return it to native vegetation.*

growth when it is conducted with a winged subsoiler that lifts and shatters the soil. Ripping can also be performed using hydraulically operated chisel teeth mounted on the back of a bulldozer, although several passes may be required to disaggregate the entire roadbed (Figure 286).

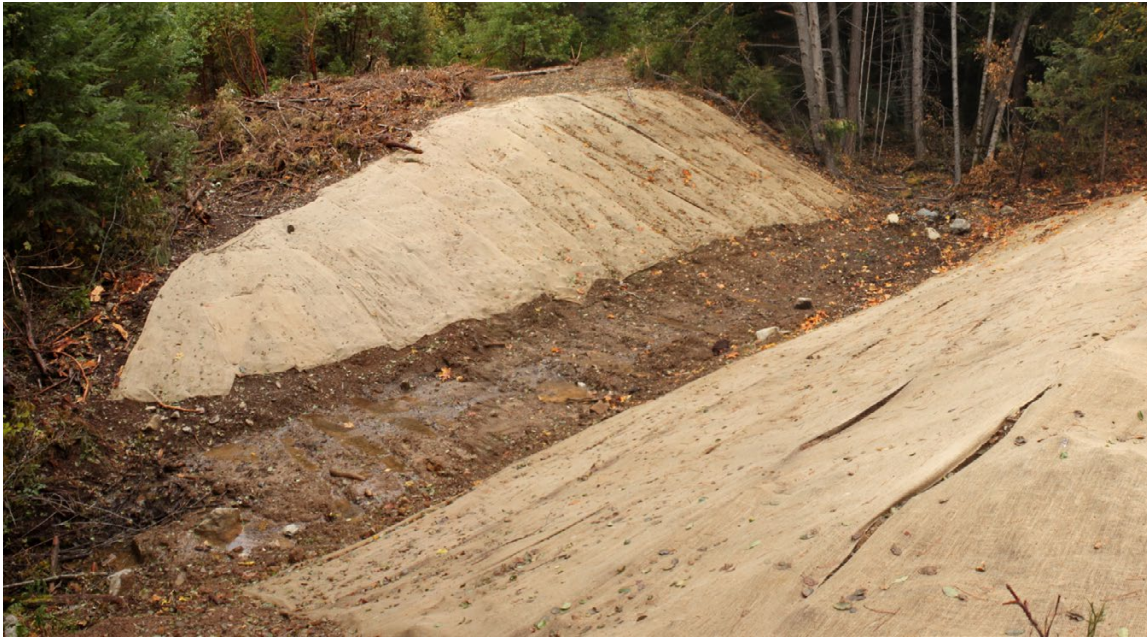
FIGURE 287. Most often, a uniform cover of straw mulch is all that is needed to temporarily control surface erosion on the excavated sideslopes of decommissioned stream crossings until they can naturally revegetate. Wood chips, or native brush and slash, also work well to control surface erosion in some environments. Here, jute netting has been used instead of straw, as a trial treatment. Rolled and tacked erosion control blankets, or jute netting tacked over a layer of straw mulch, can be used on sideslopes that are steeper than about 2:1 (50%). To avoid spreading non-native weed species, many areas can employ rice straw whose seed and weed species are not adapted to growing in most upland environments. Rice straw mulch also has a roughness or “stickiness” that allows it to hold in place on slopes steeper than wheat or grass straw.

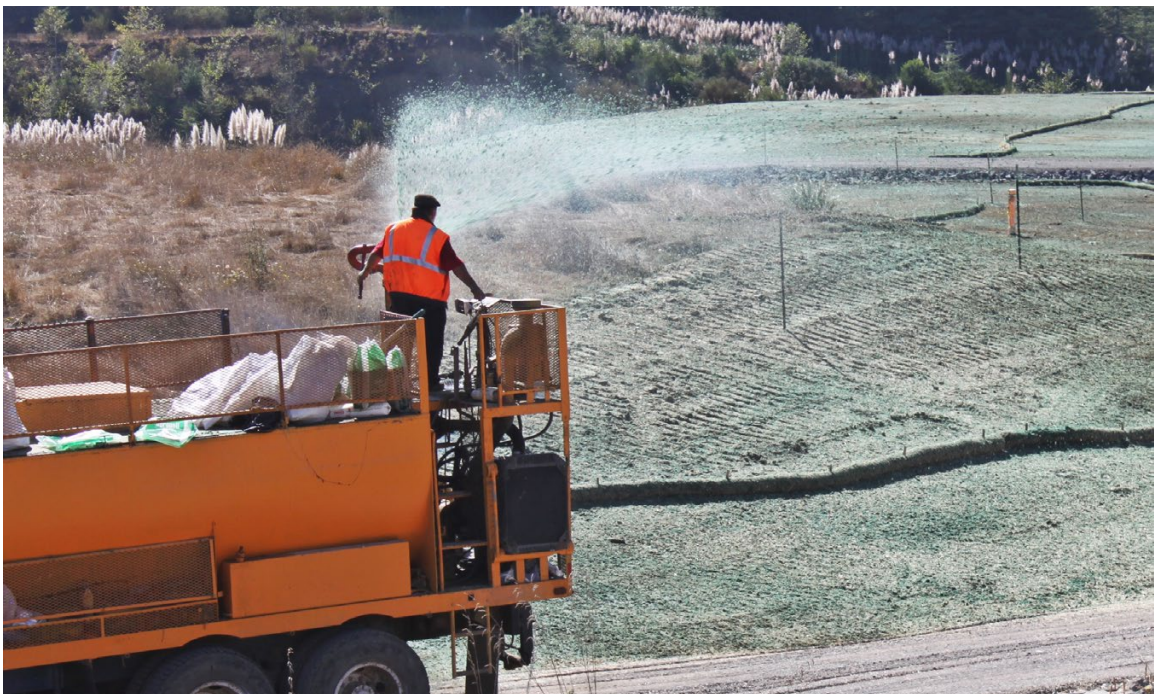
FIGURE 288. Hydroseeding (spraying a slurry of water, mulch, seed and fertilizer) on bare soil areas can be an effective erosion control and revegetation treatment for large disturbed areas, or for bare soil areas along open roads. It is most useful for treating spoil disposal sites, after they have been graded and smoothed, and for treatments along newly upgraded roads where the truck or trailer can have easy access. Hydroseeding decommissioned roads is more difficult because access is cut off as the treatments progress. Rather, hand seeding and mulching is usually the preferred treatment.

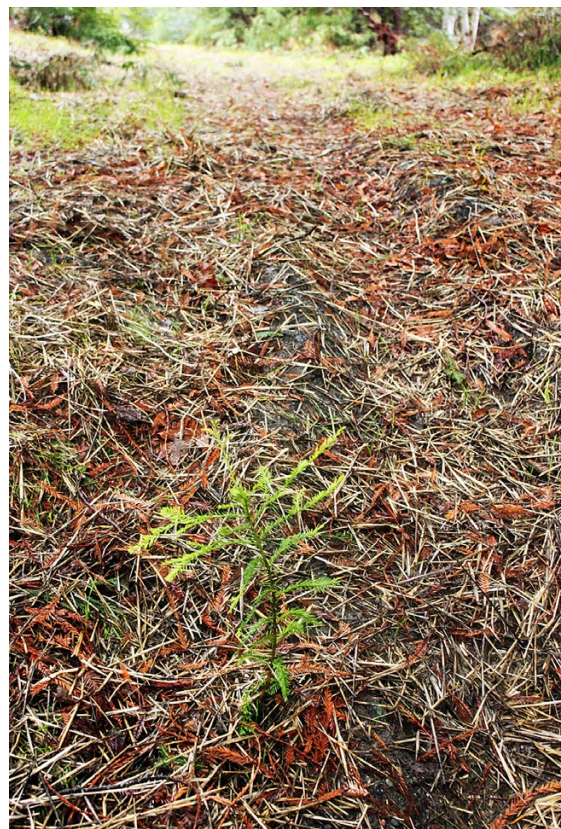
FIGURE 289. *Tree planting (or planting woody species suitable for the specific environment of the road) is the final long term treatment for the decommissioned roadbed and for the riparian sideslopes where stream crossings have been excavated and restored for the long term. This planted redwood tree, and those conifers and hardwoods that naturally seed themselves onto the former roadbed, will eventually cover the alignment and provide for long term site stability.*

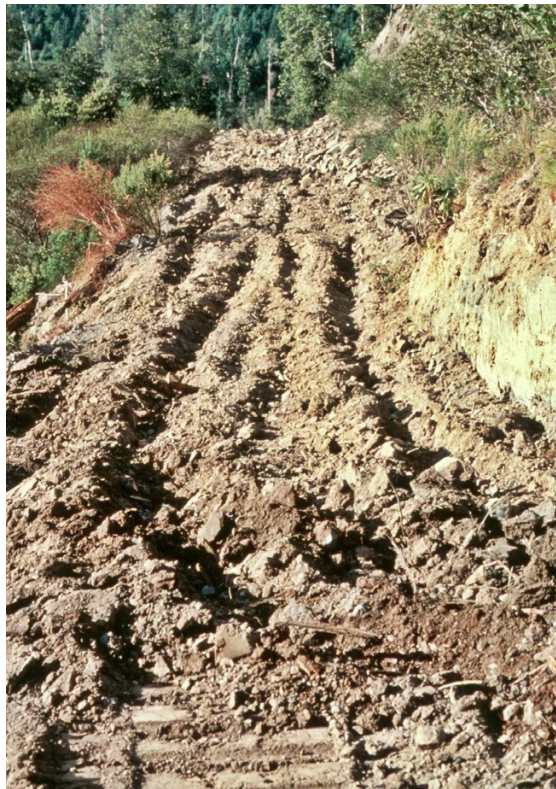
FIGURE 290. *Deep, thorough ripping is a good treatment to largely eliminate surface runoff and “hydrologically disconnect” a former road from nearby stream channels.*

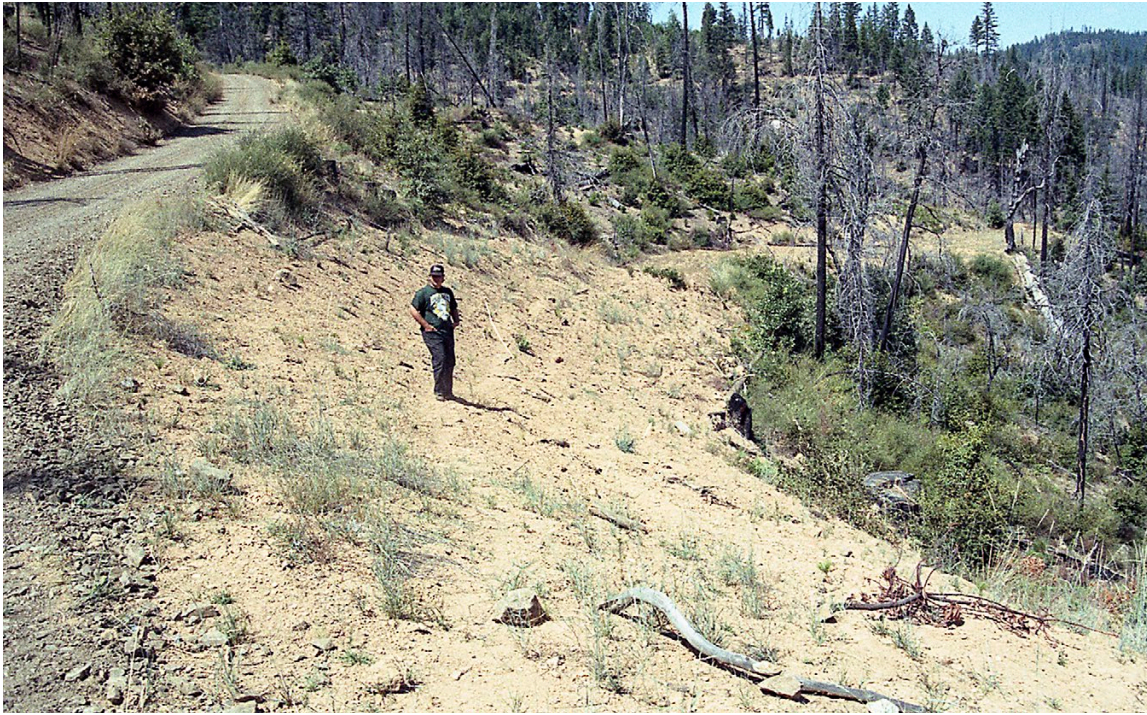
FIGURE 292. Severe outsloping, which prevents vehicle access, should only be used on temporary roads and decommissioned roads where all stream crossings have first been removed, unstable fill slopes have been excavated or stabilized, and road surface drainage is permanently dispersed. To help ensure vehicles do not use the closed road, logs, boulders and brush can be spread over the surface, especially near the beginning of the road, to discourage unwanted traffic. These roads should need no future maintenance, so vehicle access is no longer needed.
