LONG TERM ON-SITE AND OFF-SITE EFFECTS OF LOGGING AND EROSION IN THE REDWOOD CREEK BASIN, NORTHERN CALIFORNIA

Danny K. Hagans, Dr. William E. Weaver, and Mary Ann Madej,
Redwood National Park

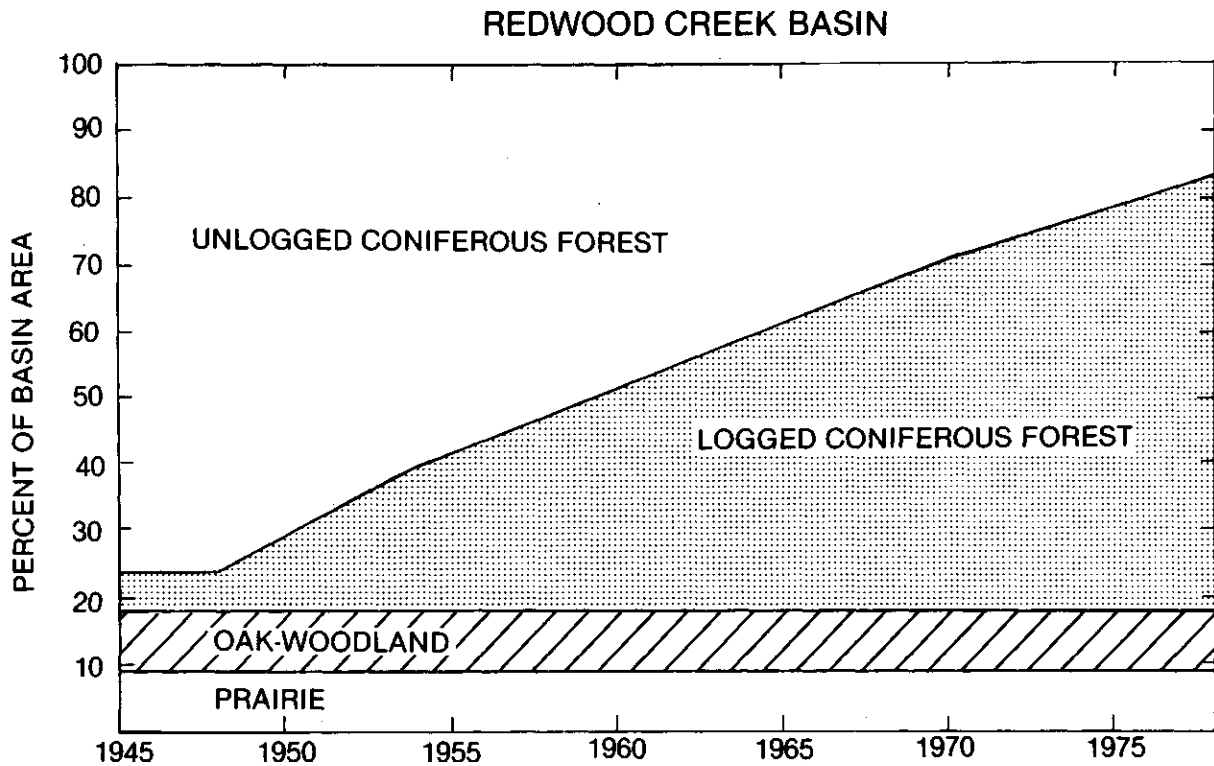
FIGURE 2

TIMBER HARVEST IN THE REDWOOD CREEK BASIN SHOWING CHANGES IN PERCENT OF BASIN LOGGED FROM 1945 TO 1978

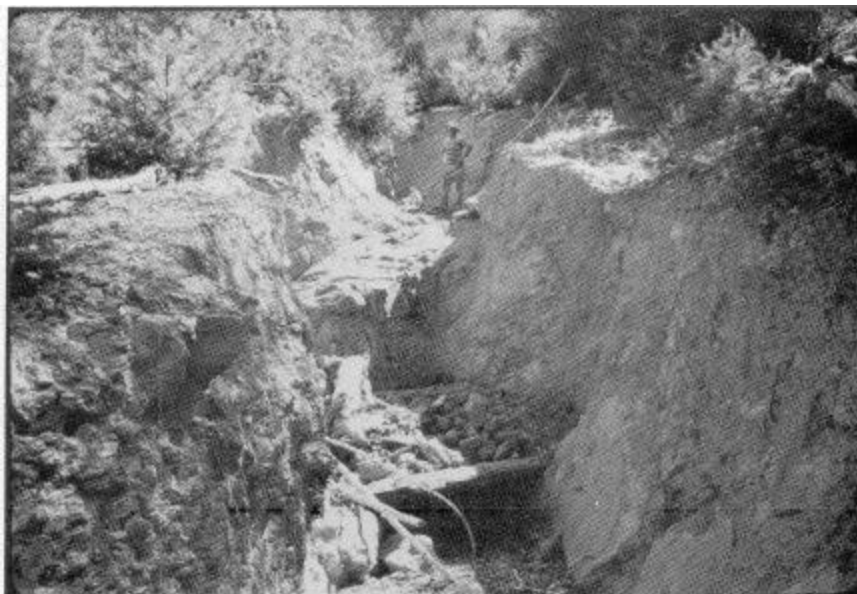
FIGURE 4

GROUND PHOTOGRAPH OF TYPICAL GULLY IN REDWOOD CREEK BASIN. GULLY AVERAGES TWO TO THREE METERS WIDE BY TWO METERS DEEP. NOTE THE INCOMPETENT NATURE OF FRANCISCAN ASSEMBLAGE BEDROCK EXPOSED IN THE GULLY WALLS. DIVERTED STREAMFLOW AT ROAD CROSSINGS FREQUENTLY DEVELOPS LARGE GULLIES BEFORE A COARSE LAG DEPOSIT CAN ACCUMULATE AND ARREST FURTHER DOWNCUTTING AND ENLARGEMENT.

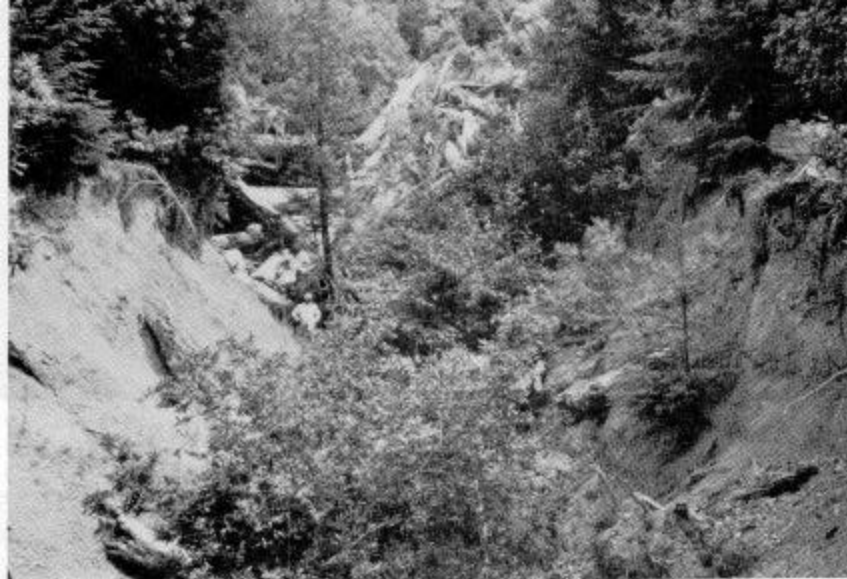
FIGURE 5

GROUND PHOTOGRAPH OF ENLARGED OR GULLIED NATURAL STREAM CHANNEL
NOTE LARGE AMOUNT OF INTRODUCED LOGGING DEBRIS (BACKGROUND)
WHICH DEFLECTS STREAMFLOW INTO SIDESLOPES AND CAUSES FURTHER
BANK EROSION

The second type of on-site effect is an increase in channel dimensions, primarily on lower order streams (first, second and some third order channels). As with increases in drainage density, the diversion of stream flow at road and skid trail stream crossings is primarily responsible for the enlargement of natural stream channels. The substantial and relatively rapid adjustments of channel morphology occur as a result of increased discharges and sediment loads. Because of the difficulty in graphically reconstructing original channel dimensions after gullying has already occurred, our approach has been to determine the length of natural stream channels which have been "significantly" enlarged or gullied, based on detailed field mapping and comparison with unimpacted reaches. Enlarged channels display near vertical and raw streambanks and are characterized by abundant young vegetation which is actively toppling from the sideslopes into the stream channel, (Figure 5).

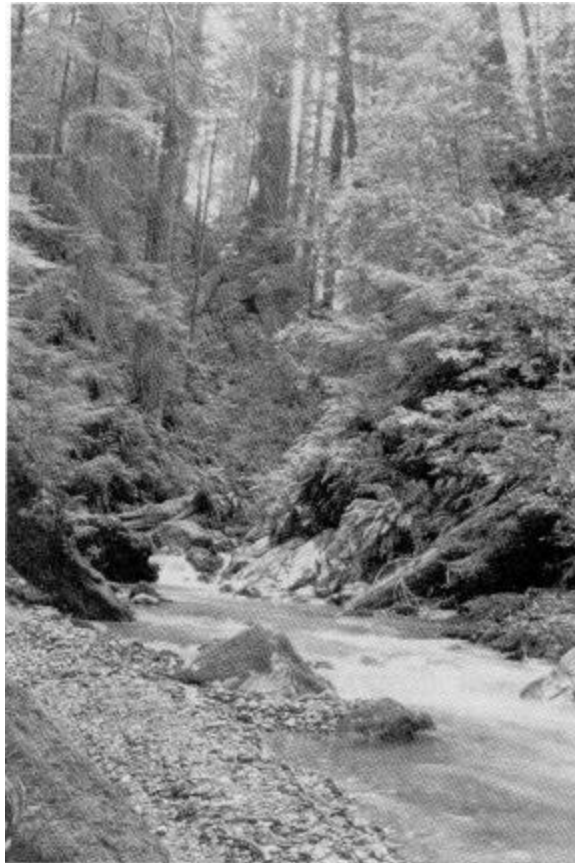
FIGURE 7

CHANNEL OF DEVILS CREEK
(NEAR SOUTH PARK BOUNDARY)
EXHIBITS COMMON CHARACTER-
ISTICS OF REDWOOD CREEK
TRIBUTARY STREAMS: STEEP
SIDESLOPES, COARSE BED
MATERIAL AND LITTLE
FLOODPLAIN DEVELOPMENT

Long term changes in channel geometry do not seem as widespread in steep third, fourth and fifth order tributaries when compared to the effects on the hillslopes and in small streams. Much of this lack of persistent changes or effects appears to be controlled by channel gradient which in turn affects residence times of introduced sediment. Most of these higher order tributaries have average gradients between 0.05 and 0.30 m/m and drain small watersheds ranging from 1.6 to 44 km². Their channels are, in general, deeply incised and have narrow, discontinuous floodplains (Figure 7).

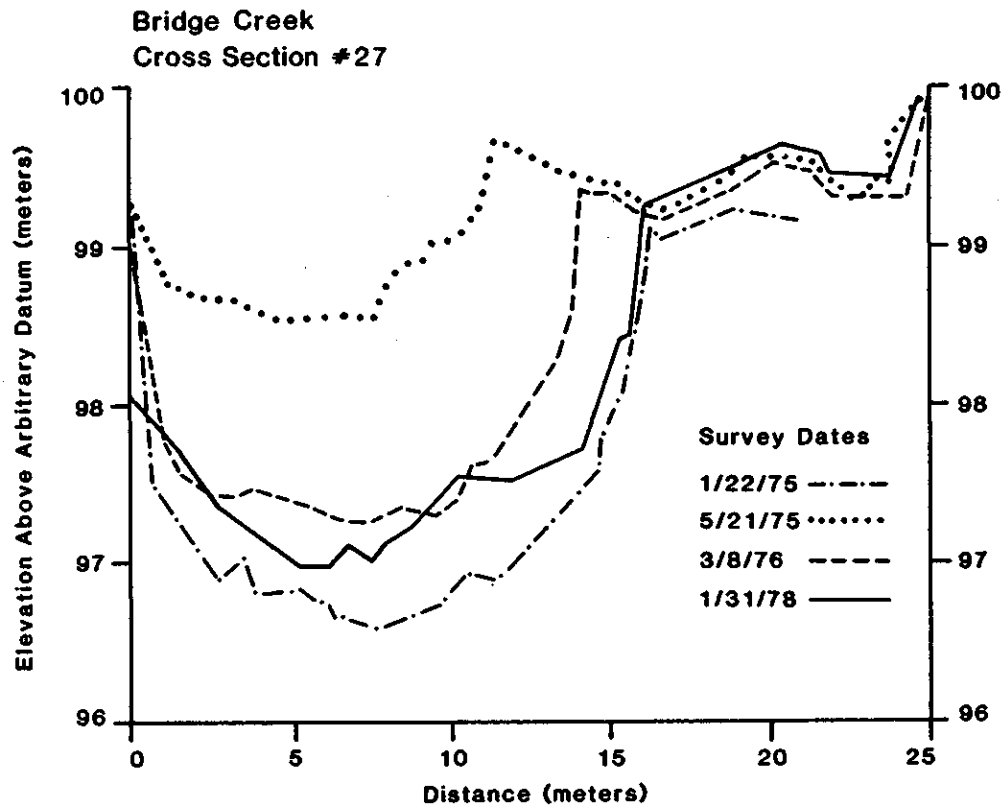
FIGURE 9

BRIDGE CREEK CHANNEL CROSS SECTIONS MEASURED OVER A THREE YEAR PERIOD ILLUSTRATE THE SHORT RESIDENCE TIME OF STORED SEDIMENT IN MANY HIGHER ORDER TRIBUTARY STREAMS OF REDWOOD CREEK

Tributary efficiency is exemplified in a series of cross-sections surveyed near the mouth of the 29.4 km² Bridge Creek watershed (Figure 9). It illustrates the exceptionally short residence time of stored sediment in many higher order tributary streams. One year after the March 1975 flood had deposited over two meters of sediment in the channel, well over one meter of degradation had occurred throughout the cross-section. Within

just three years, the channel had flushed out virtually all the introduced sediment and returned to near its original configuration with little evidence of major secondary changes in channel geometry (e.g., bank erosion).

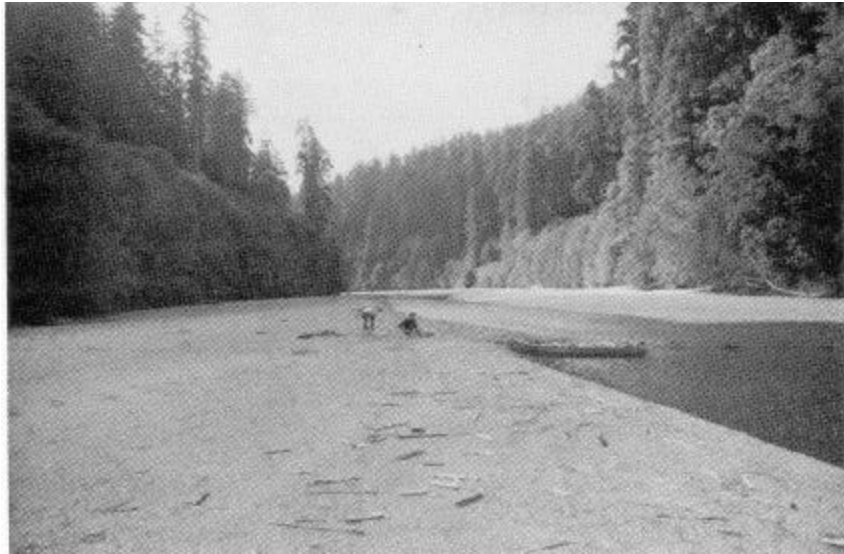
FIGURE 10

GROUND PHOTOGRAPH OF TYPICAL CHANNEL CONDITIONS IN THE LOWER 20 km OF REDWOOD CREEK. THE CHANNEL IS AGGRADED, BROAD, EXPERIENCES FREQUENT THALWEG SHIFTING, AND LOCALLY DISPLAYS MULTIPLE CHANNELS DURING SUMMER LOW-FLOW CONDITIONS

Even though major geomorphic effects are commonly absent in larger tributaries, our studies show they are persistent and widespread in the main stem of Redwood Creek. There, much of the sediment eroded from hillslopes is temporarily stored in the channel bed. Pools fill as the channel aggrades, and gravel bars become larger and more extensive to accommodate this influx of sediment (Figure 10).

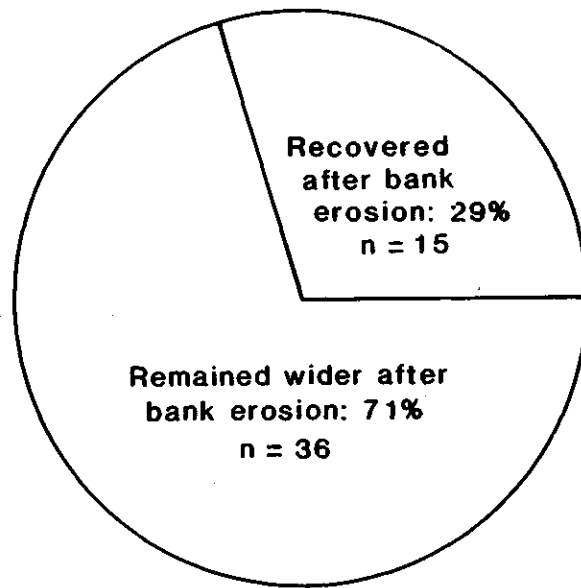
FIGURE 12

PIE DIAGRAM DEMONSTRATING PERSISTENT CHANGES IN CHANNEL WIDTH CAUSED BY MAJOR (GREATER THAN 6 METER) BANK EROSION ON A 30 km SAMPLE REACH OF REDWOOD CREEK BETWEEN 1955 AND 1978

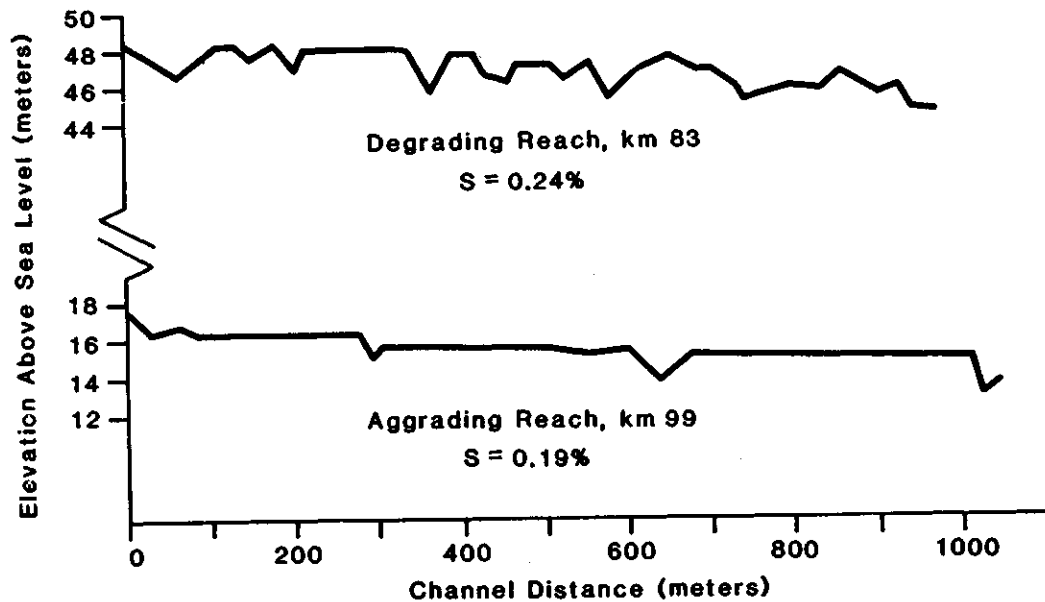
FIGURE 14

A COMPARISON OF LONGITUDINAL PROFILES FOR TWO SEPARATE 1000 METER REACHES WITH SIMILAR CHANNEL GRADIENTS IN THE LOWER REDWOOD CREEK BASIN. THEODOLITE AND ELECTRONIC DISTANCE METER SURVEYS WERE PERFORMED DURING THE SUMMERS OF 1977 AND 1983

Thalweg slopes were calculated by regression analysis of theodolite surveys and the associated coefficients of determination (r^2) were calculated for the reaches. The r^2 value associated with the upstream reach (0.62) is lower than that for the downstream reach (0.93). The lower r^2 value in the upstream channel segment reflects the increase in bed variation seen in recovering reaches, where the most well defined pool-riffle sequence occurs (Figure 14). Conversely, the higher values of r^2 are associated with aggrading reaches of Redwood Creek where pools are not as deep or frequent (14). Presently, there are 15 km of channel in lower Redwood Creek that are actively aggrading. Thus, in reaches where Redwood Creek stores increased amounts of sediment, and streambeds are aggraded to higher than pre-disturbance elevations, pool frequencies are reduced.

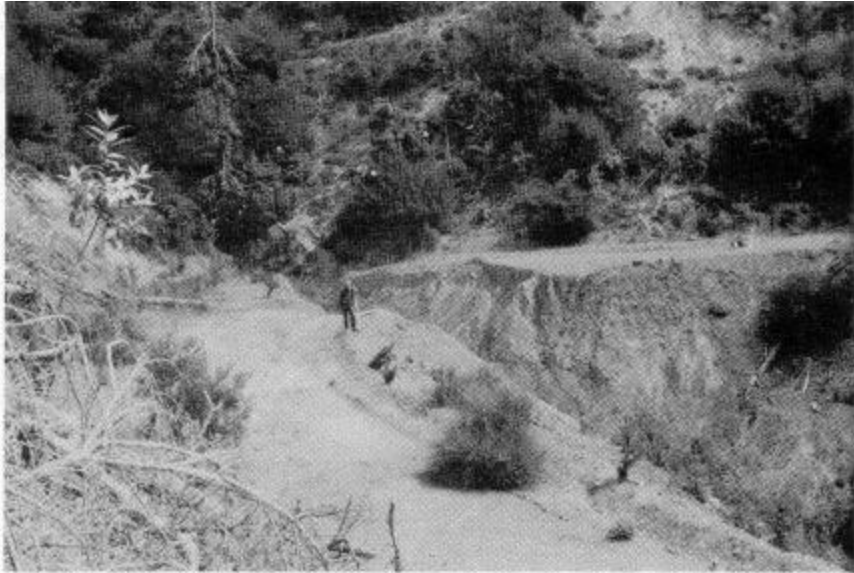
FIGURE 16

ABANDONED LOGGING ROAD STREAM CROSSING CONSTRUCTED WITH NO DIVERSION POTENTIAL. THE ROAD RISES AT THREE DEGREES IN BOTH DIRECTIONS FROM THE STREAM CHANNEL. SINCE STREAM DIVERSIONS AT THIS TYPE OF CROSSING CANNOT OCCUR, EROSIONAL PROBLEMS ARE CONFINED TO FAILED ("WASHED OUT") STREAM CROSSINGS. VOLUME OF

channel at the crossing (Figure 16). Even if the culvert plugs, flow cannot escape the drainage system. For the five crossings with high diversion potentials, the road surface was found to slope away (down) from the stream crossing in at least one direction (Figure 17).

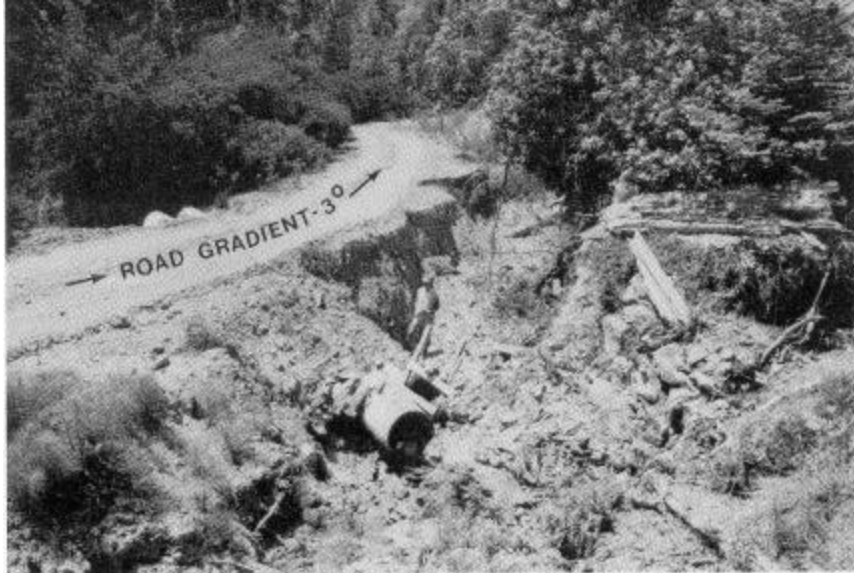
FIGURE 17

LOGGING ROAD STREAM CROSSING CONSTRUCTED WITH A HIGH DIVERSION POTENTIAL. CULVERTS SHOW ORIGINAL ORIENTATION OF STREAM CHANNEL IN RELATION TO ROAD. NOTE GULLIED INBOARD DITCH DOWN ROAD FROM POINT OF STREAM DIVERSION (CULVERT INLET). STREAM DIVERSIONS IN THE REDWOOD CREEK BASIN FREQUENTLY CREATE GULLY NETWORKS ON ADJACENT HILLSLOPES WHICH MAY YIELD 2,000 TO 4,000 m³ OF ERODED SEDIMENT
